Controller's Misperception of Aircraft Positions Sets Stage for Collision on Runway in Paris

The investigation generated recommendations about the practice of clearing more than one aircraft onto a runway, the terminology used in takeoff clearances, coordination among controllers and the use of different languages in controller-pilot communication.

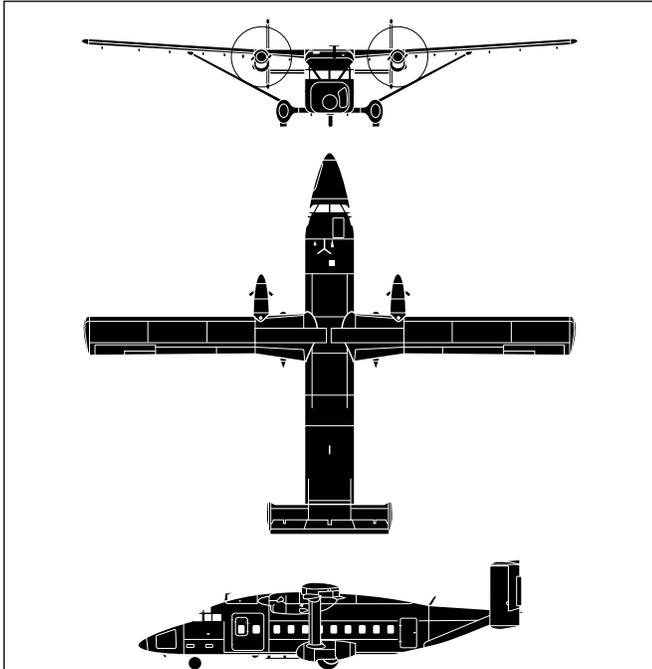
The Short Brothers SD3-30 (Shorts 330) is a twin-turboprop, short-range commuter/regional transport derived from the SC.7 Skyvan, a short-takeoff-and-landing (STOL) utility transport that first flew in 1963 with reciprocating engines and later was equipped with turboprop engines. The 330, which has a larger cabin than the Skyvan and retractable landing gear, first flew in 1974.

Takeoff distance at maximum takeoff weight and standard atmospheric conditions is 1,159 meters (3,800 feet). Maximum rate of climb at sea level is 1,180 feet per minute. Single-engine service ceiling is 11,500 feet. At 9,525 kilograms (21,000 pounds) and 10,000 feet, maximum cruising speed is 190 knots and economy cruising speed is 160 knots. Range at 10,000 feet with 30 passengers and no fuel reserves is 876 kilometers (473 nautical miles). Stall speed at maximum landing weight and in landing configuration is 73 knots.♦

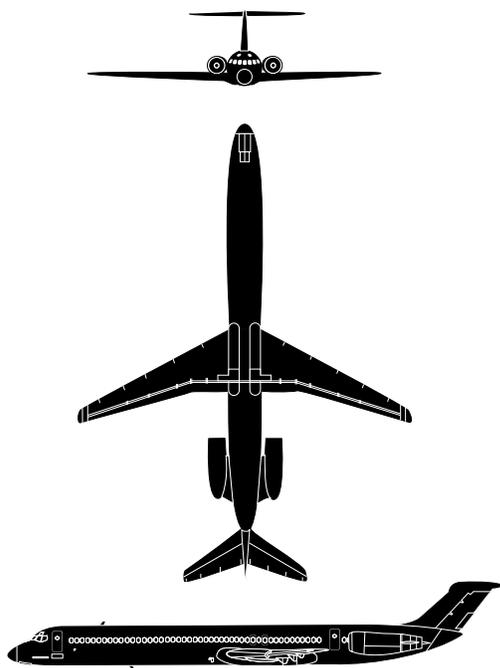
McDonnell Douglas MD-83

The MD-80 series jet transports are derivatives of the Douglas DC-9, which first flew in 1965. Douglas Aircraft Co. and McDonnell Co. merged in 1967 to form McDonnell Douglas Corp. The MD-80, originally called the Super 80, has longer wings, a longer fuselage and more fuel capacity than the DC-9, and an integrated digital flight control system.
