Low Visibility and Citation Crew's Deviation From Taxi Instructions Lead to Collision With MD-87

Runway visual range was about 200 meters/700 feet when the crew of a Cessna Citation CJ2 taxied on the wrong taxiway and into the path of a Boeing MD-87 that was taking off on the active runway at Milan, Italy.

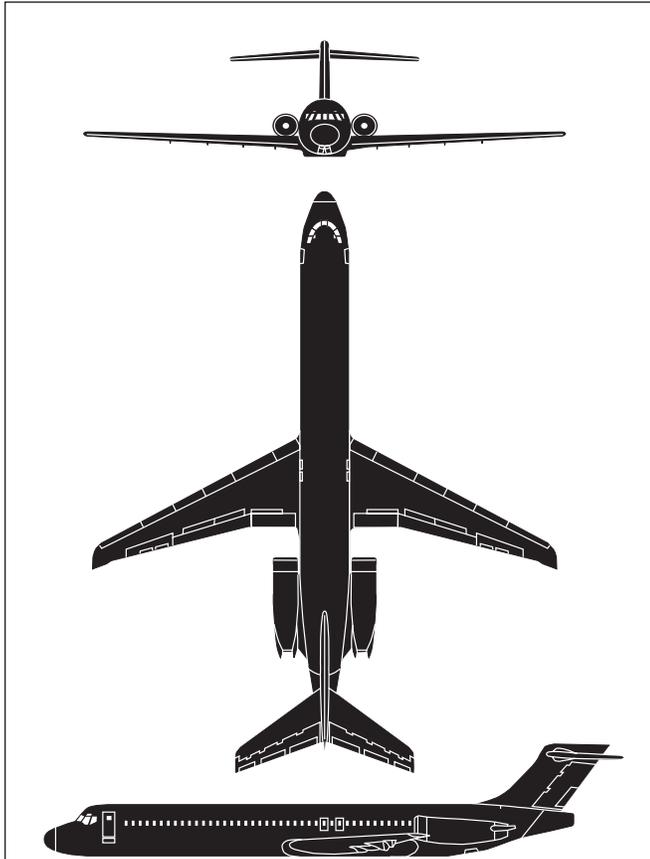
Boeing MD-87

The MD-80 series short/medium-range jet transports are derivatives of the Douglas DC-9, which first flew in 1965. Originally called the Super 80, the MD-80 has longer wings, a longer fuselage and more fuel capacity than the DC-9, and is equipped with a digital flight control system. The MD-80 prototype flew in 1979, and the airplane entered production in 1980 as the MD-81.

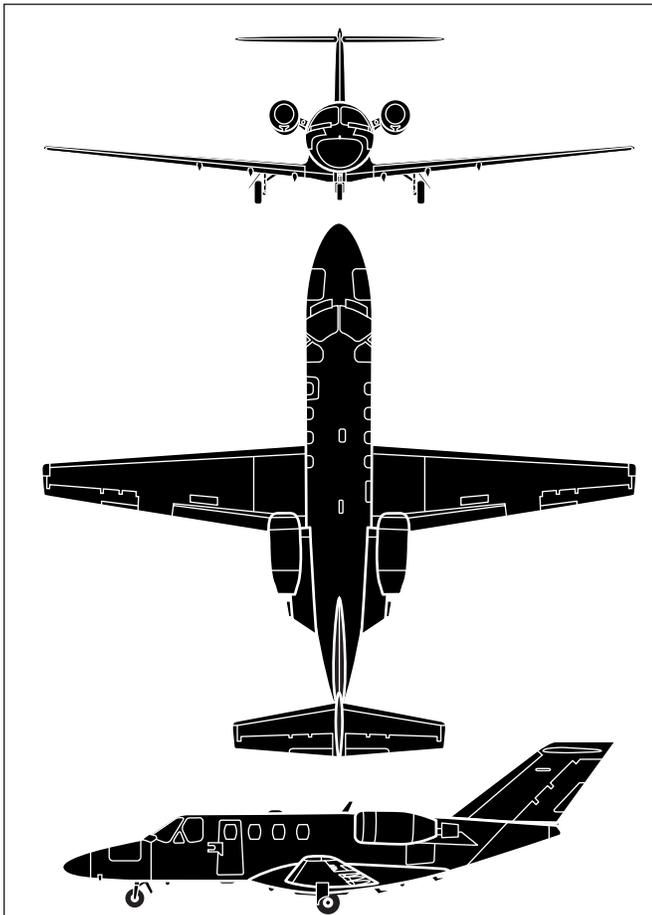
Cessna Citation CJ2

Cessna Aircraft Co. announced in 1968 the development of an eight-seat executive jet called the Fanjet 500. When the prototype flew in 1969, the name was changed to Citation. Produced from 1971 to 1976, the Citation was succeeded by the Citation I, which has a longer wing and more powerful engines. Production of the Citation I was terminated in 1985.
