MARGIN FOR ERROR

Enhancing overrun survivability with runway end safety areas.

BY MARK LACAGNINA

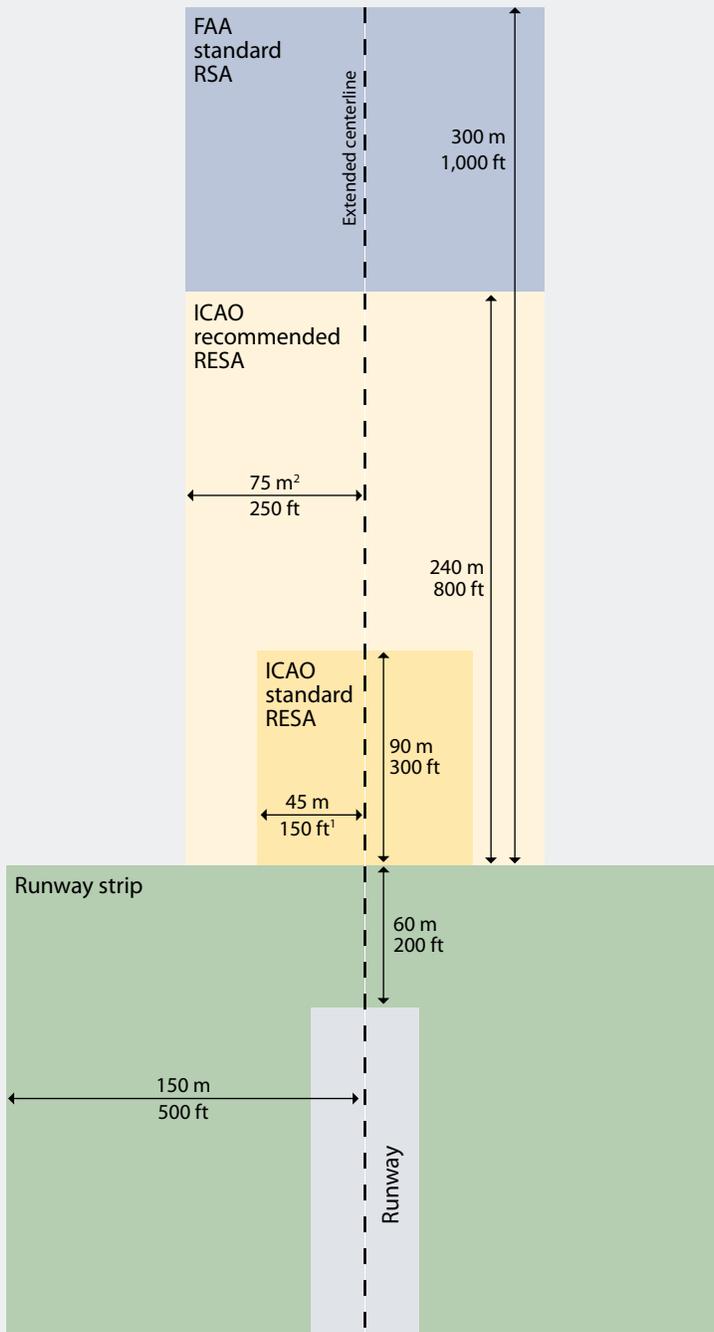
Runway Strip and Safety Area Standards

RESA = runway end safety area; RSA = runway safety area; FAA = U.S. Federal Aviation Administration; ICAO = International Civil Aviation Organization

Required minimum strip lengths beyond the runway end are 60 m/200 ft for Code 2, 3 and 4 runways, and Code 1 runways with instrument approaches; and 30 m/100 ft for Code 1 runways without instrument approaches. Required minimum strip widths for runways with precision approaches are 300 m/1,000 ft for Codes 3 and 4, and 150 m/500 ft for Codes 1 and 2. These widths also are recommended for runways with nonprecision approaches. For runways without instrument approaches, the recommended strip widths are 150 m for Codes 3 and 4, 80 m/260 ft for Code 2 and 30 m for Code 1.

At the same time, ICAO established a new recommendation: Annex 14 now says that, "as far as practicable," the RESA should extend at least 240 m/800 ft from the strips on Code 3 and 4 runways, and at least 120 m/400 ft from the strips on Code 1 and 2 runways.
