Learjet Strikes Houses, Terrain After Inadvertent Retraction of Flaps

—
FSF Editorial Staff

At 0639 local time Aug. 4, 2003, a Learjet 35A struck three houses, two groups of trees and a river as the crew performed a circling maneuver for a second attempt at landing at the Groton/New London (Connecticut, U.S.) Airport after a positioning flight from Farmingdale, New York. The airplane was destroyed, and the two crewmembers — the only people in the airplane — were killed.¹

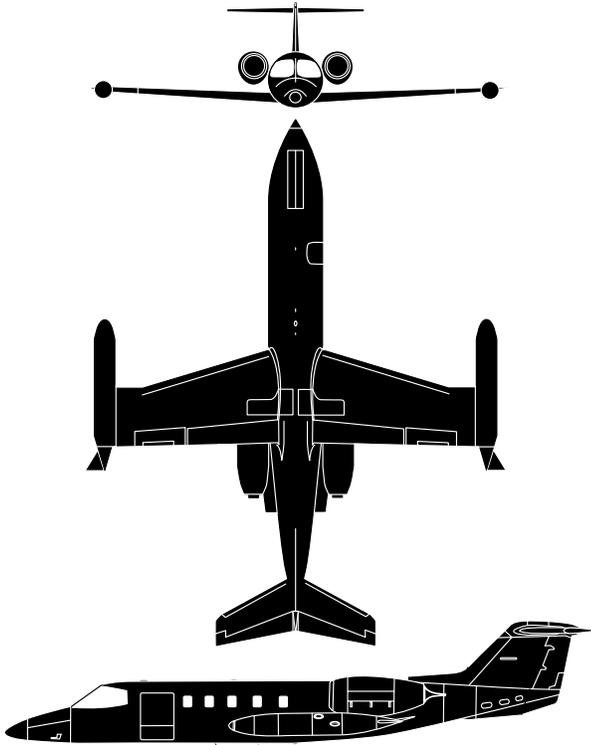
The Learjet 35 made its first flight in 1973; deliveries began in 1974. The airplane is similar to the Learjet 25 but has turboprop engines rather than turbojet engines, a longer fuselage and longer wings. The Learjet 35A was introduced in 1976 with "Century III" modifications designed to improve low-speed handling and performance; the modifications included increased wing-leading-edge camber and an improved stall-warning system. "Sofflite" wing modifications designed to improve the airplane's stall characteristics were introduced in 1979; the modifications included full-chord stall fences and boundary-layer energizers.
