King Air C90 Pilot Continues Takeoff After Engine Fails at Minimum-control Speed

The landing gear were not retracted, and the propeller on the failed engine was not feathered. A control loss occurred, and the aircraft struck terrain. Before the accident, engine-condition trend-monitoring data indicated that a potentially significant problem was developing in the engine.

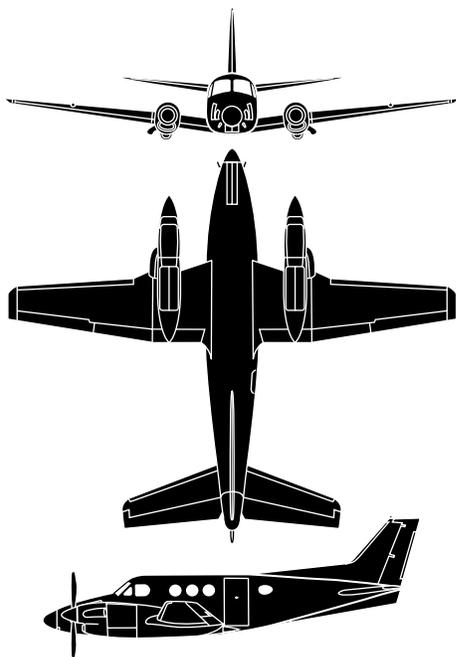
Raytheon Beech King Air C90

Beech Aircraft Corp. (now Raytheon Aircraft Co.) introduced the King Air C90 in 1970. The airplane has accommodations for a pilot and up to nine passengers, and is powered by two Pratt & Whitney Canada PT6A-20 turboprop engines, each rated at 550 equivalent horsepower (410 kilowatts) and driving a three-blade Hartzell propeller. Bleed air from both engines provides cabin pressurization; the cabins of previous 90-series King Airs were pressurized by a single hydraulically driven supercharger.

Maximum takeoff weight is 4,377 kilograms (9,650 pounds). Maximum landing weight is 4,159 kilograms (9,169 pounds).
