Noncompliance With Departure Procedures Sets Course for Impact With Mountain

Investigators said that the controlled-flight-into-terrain accident resulted from the flight crew's failure to properly plan for a night departure from an unfamiliar airport. The crew of the U.S. Air Force C-130H did not follow published instrument departure procedures.

At 2250 local time Aug. 17, 1996, a U.S. Air Force (Lockheed) C-130H struck a mountain ridge during departure from Jackson Hole Airport in Jackson, Wyoming, U.S. The aircraft was destroyed, and the eight crewmembers and a passenger were killed.

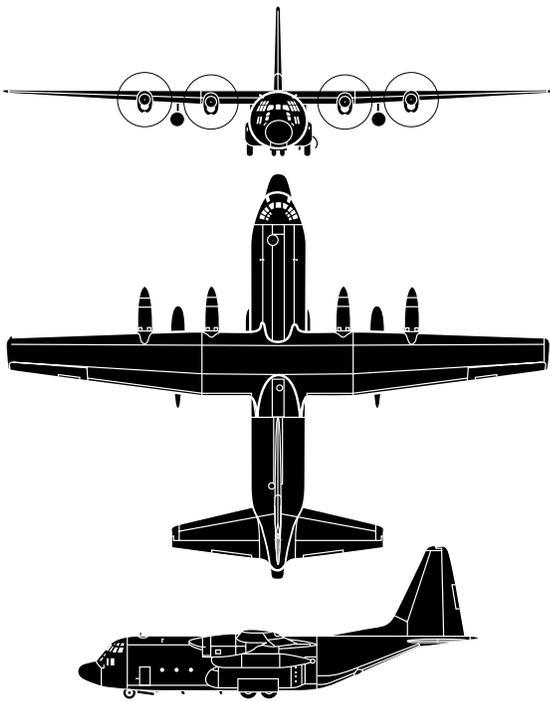
U.S. Air Force C-130H

C-130 is the U.S. Air Force designation for the Lockheed 382 Hercules. The medium-range to long-range combat transport aircraft was designed to an Air Force specification issued in 1951. Deliveries of the C-130 began in 1952.

The flight deck has accommodations for five crewmembers. The aircraft has a galley and sleeping quarters for relief crewmembers. The cabin can accommodate 92 regular troops or 64 paratroops. The flight deck and main cabin are air-conditioned and pressurized. Maximum pressure differential is 7.5 pounds per square inch (0.52 bar).
