Rapid Ice Buildup Triggers Stall and In-flight Breakup

While being flown in an area of severe icing conditions in New Zealand, the Convair 580 freighter stalled and entered a spiral dive from which the flight crew was not able to recover. The aircraft broke up and struck water nearly vertically and at a high rate of speed.

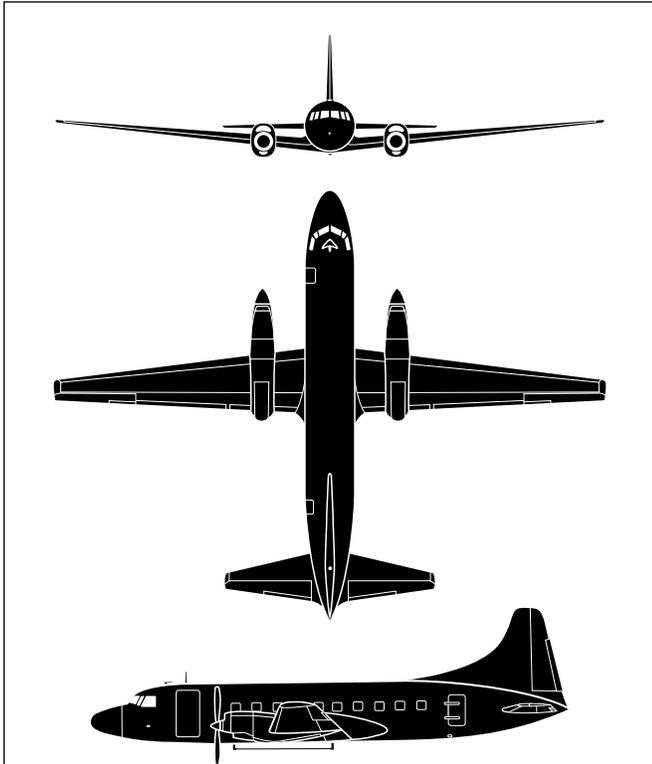
Consolidated Vultee Corp. Convair 580

The Convair 580 is a turboprop conversion of the piston-engine-powered Convair 340 and 440. The conversion included replacement of the 1,800-horsepower (1,343-kilowatt) 18-cylinder Pratt & Whitney R-2800 radial engines with 3,750-shaft-horsepower (2,798-kilowatt) Allison 501-D13 turboprop engines and enlargement of the empennage surfaces. Optional modifications included increased fuel capacity.
