FLIGHT SAFETY FOUNDATION

Accident Prevention

July 2004

Improper Response to Stall Warning Cited in A310 CFIT off Ivory Coast

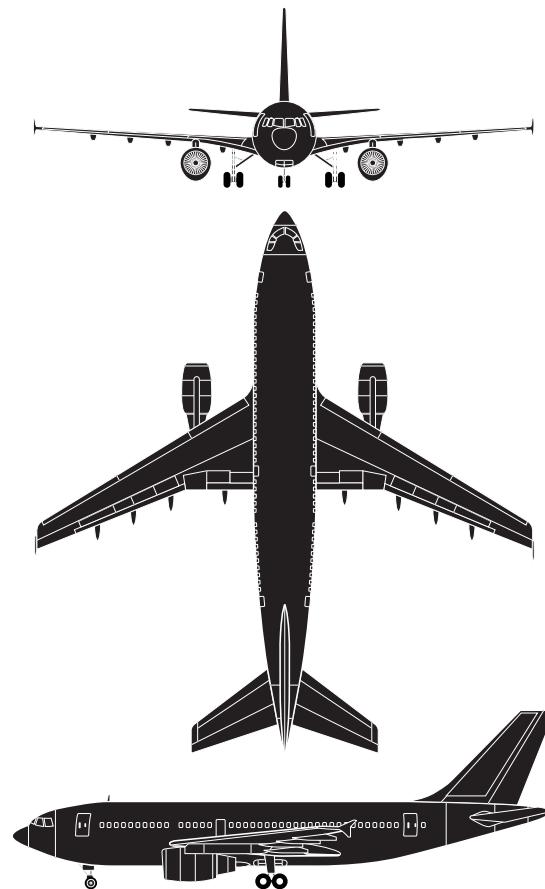
Airbus A310-300

Introduced into service in 1983, the Airbus A310 has a shorter fuselage and smaller wings and horizontal tail surfaces than the A300. The A310-300 is an extended-range version that was first flown in 1985 and is the first Airbus airplane to have triangle-shaped wing tip fences, which were developed to reduce drag.
