Absence of Aircraft Load Data Cited in Failed Takeoff in Benin

No documents accurately showed the B-727's weight and balance. The airplane's takeoff weight likely was higher and its center of gravity likely was farther forward than the values calculated by the flight crew. High-density-altitude conditions prevailed during the attempted departure from a relatively short runway.

FSF Editorial Staff

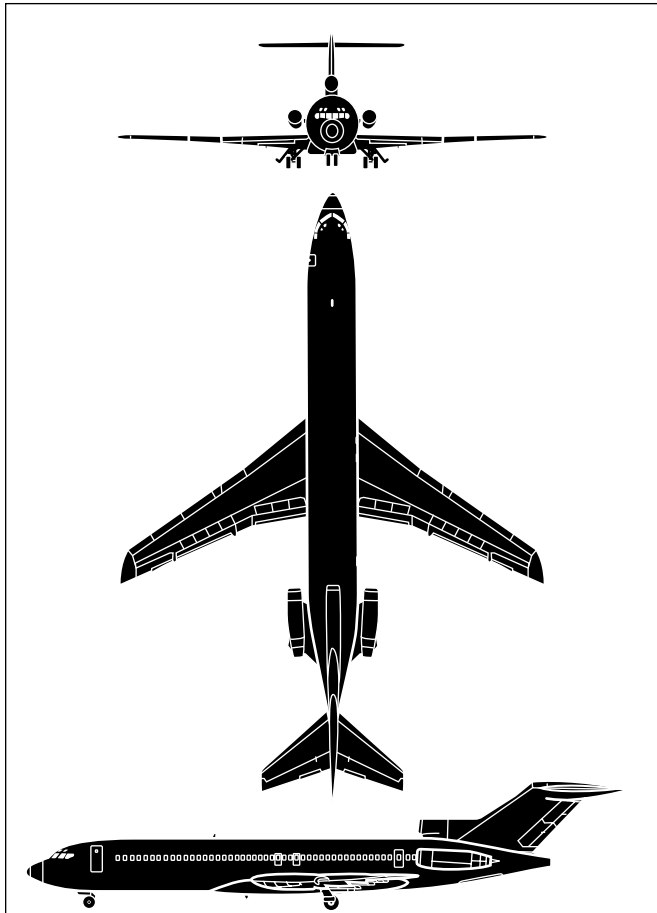
Boeing 727-200

The three-engine, short/medium-range B-727 was introduced into service in 1960. The B-727-200, introduced in 1967, is a "stretched" version, with three-meter (10-foot) fuselage extensions both forward and aft of the main landing gear wheel wells.
