## B-737 Strikes Terrain After Power Loss Occurs on Takeoff

*The airplane was near gross weight during departure from an Algerian airport. The left engine failed but the crew did not retract the landing gear. Pitch attitude for a normal all-engine initial climb was maintained, and airspeed decreased to stall speed.*

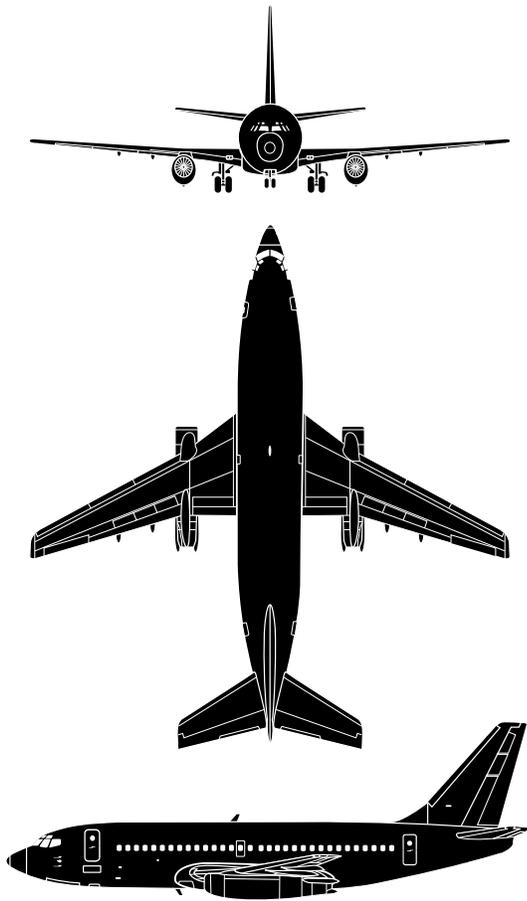
### Boeing 737-200 Advanced

The Boeing 737 originally was designed as a short-range jet transport that would use many components already in production for the B-727. Deliveries of the B-737-100 began in 1967. Fewer than 30 of the 100-series airplanes were built before the model was replaced with the B-737-200, which had a 193-centimeter (76-inch) longer fuselage and accommodated 12 more passengers. The B-737-200 Advanced, introduced in 1971, has aerodynamic improvements, including modified wing-leading-edge slats, Krueger flaps and engine-nacelle fairings.
