Crew Loses Control of Boeing 737 While Maneuvering to Land

The airplane was high on approach to Patna, India, and the crew received clearance from air traffic control to conduct a 360-degree turn to reposition for landing. The airplane stalled and descended into a residential area. Fifty-five occupants of the airplane and five people on the ground were killed in the approach-and-landing accident.

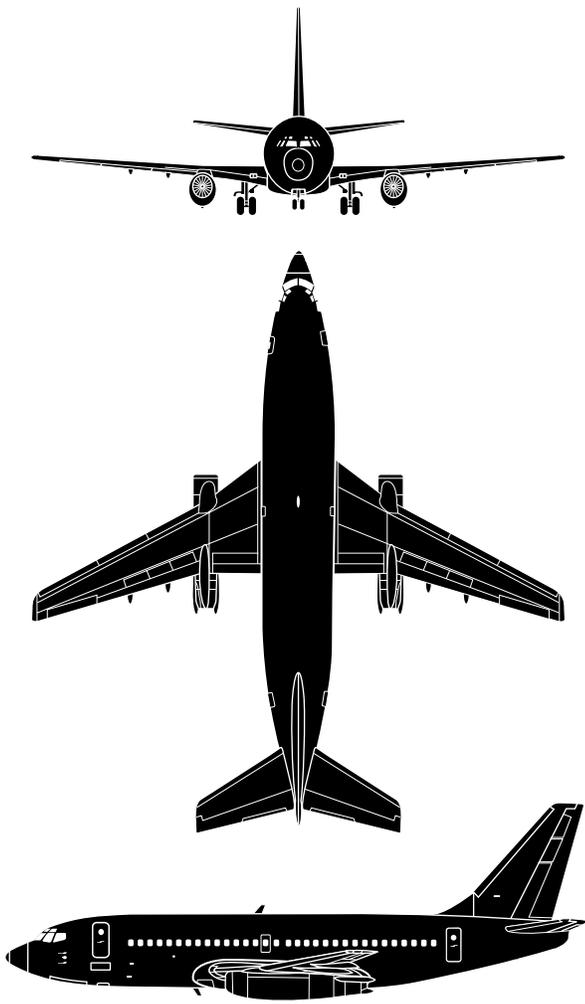
Boeing 737-200 Advanced

The Boeing 737 originally was designed as a short-range jet transport that would use many components already in production for the B-727. Deliveries of the B-737-100 began in 1967. Fewer than 30 of the 100-series airplanes were built before the model was replaced with the B-737-200, which had a 76-inch (193-centimeter) longer fuselage and accommodated 12 more passengers. The B-737-200 Advanced, introduced in 1971, has aerodynamic improvements, including modified wing-leading-edge slats, Krueger flaps and engine-nacelle fairings.

Standard accommodation is for two flight crewmembers and up to 120 passengers. Standard maximum ramp weight is 115,500 pounds (52,391 kilograms). Maximum landing weight is 103,000 pounds (46,721 kilograms).
