Destabilized Approach Results in MD-11 Bounced Landing, Structural Failure

—
FSF Editorial Staff

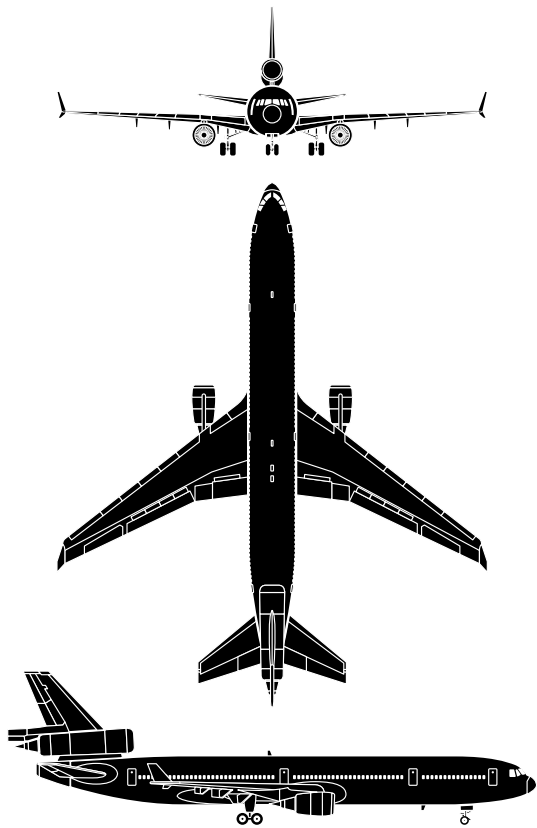
McDonnell Douglas MD-11

The McDonnell Douglas MD-11, a medium/long-range passenger/freight transport airplane, entered service in 1990. A derivative of the Douglas DC-10, the MD-11 has a two-pilot, all-digital flight deck; winglets above and below each wing tip; and a redesigned tail incorporating a 2,000-gallon (7,570-liter) fuel-trim tank.

The standard passenger version has accommodations for 323 passengers. The mixed passenger/cargo (combi) version has accommodations for 214 passengers.
