Darkness Increases Risks of Flight

Human perceptual limitations are blamed for specific types of accidents that are more likely to occur in darkness than in daylight. Special hazards associated with night flying continue to cause accidents despite efforts to inform pilots of the risks.

—
Dale R. Wilson
Central Washington University

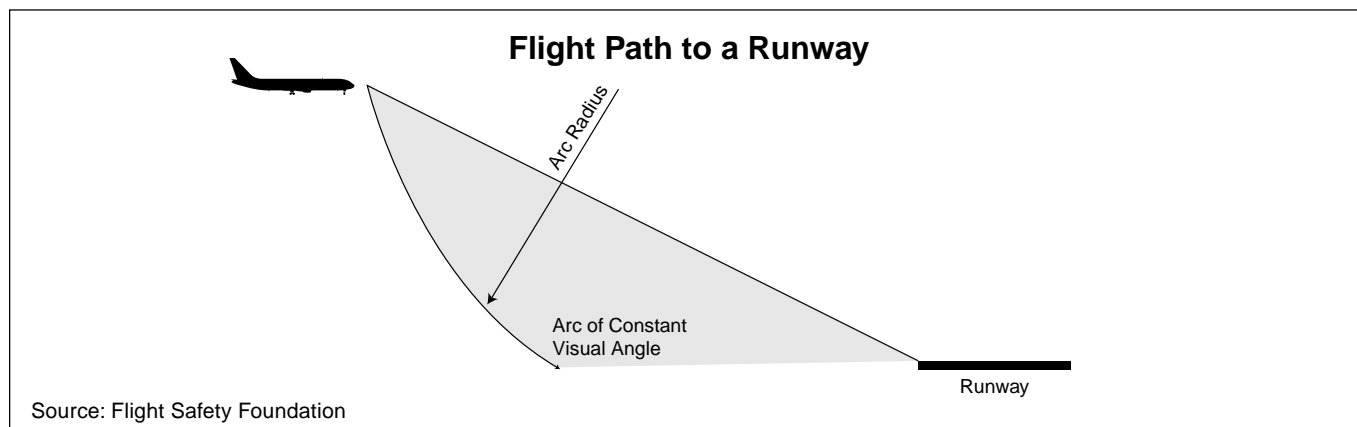
Figure 1

One explanation, according to research conducted in the 1960s for The Boeing Co., centers on the angle of the light pattern on the ground as seen by pilots approaching a city — and the city's nearby airport — at a constant altitude.²⁸ As the airplane approaches the city, the angle becomes increasingly greater, but from any specific altitude and distance, there is one specific flight path that enables the pilot to keep the visual angle constant. That path follows the arc of a circle (Figure 1) that is centered above city lights with its circumference contacting the ground, and the pilot believes — incorrectly — that the aircraft is in a straight-line descent. Following that path to the airport is satisfactory as long as the pilot is flying over flat terrain. But the research, which included simulator flights by senior instructor-pilots, found that

when irregular light patterns or upslope lights or other variations were introduced, a number of pilots flew approach paths that were too low — and in one simulation, a pilot flew to an altitude 2,500 feet below airport elevation.

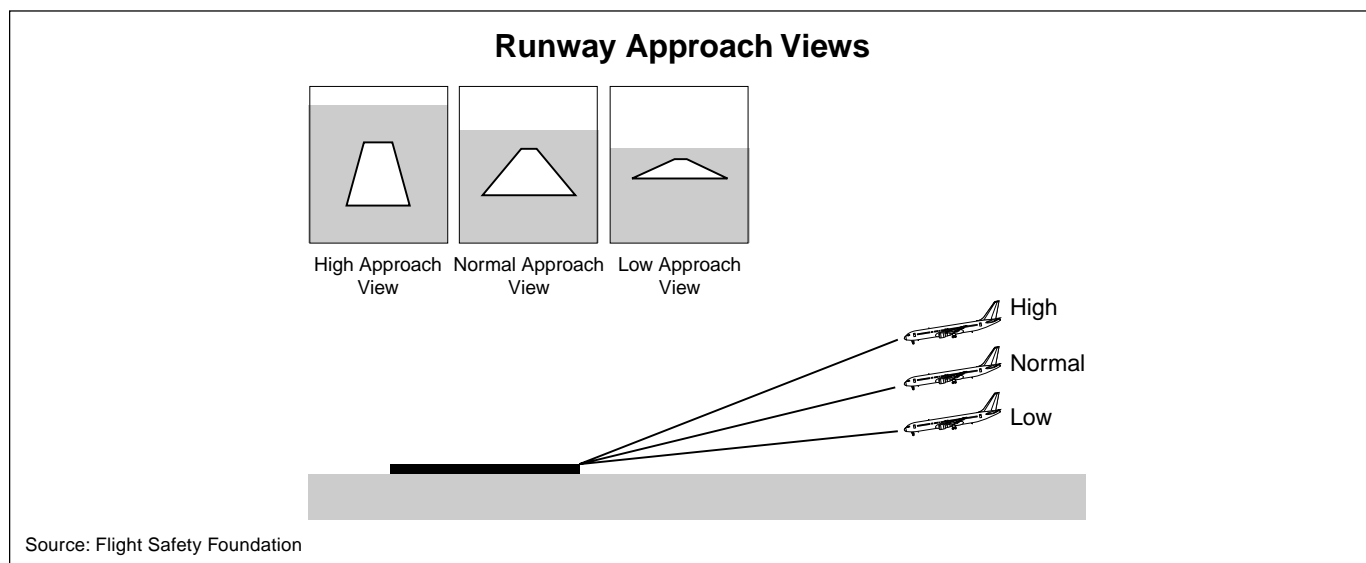
Figure 2

During the day, a pilot's depth perception helps estimate the distance to an airport, as well as the aircraft's height above it (Figure 2). But in darkness, with the absence of visual clues, such as shadows, topographical references and color variations, the pilot has little or no depth perception. Without depth perception, estimating distance and height becomes more difficult.³⁰

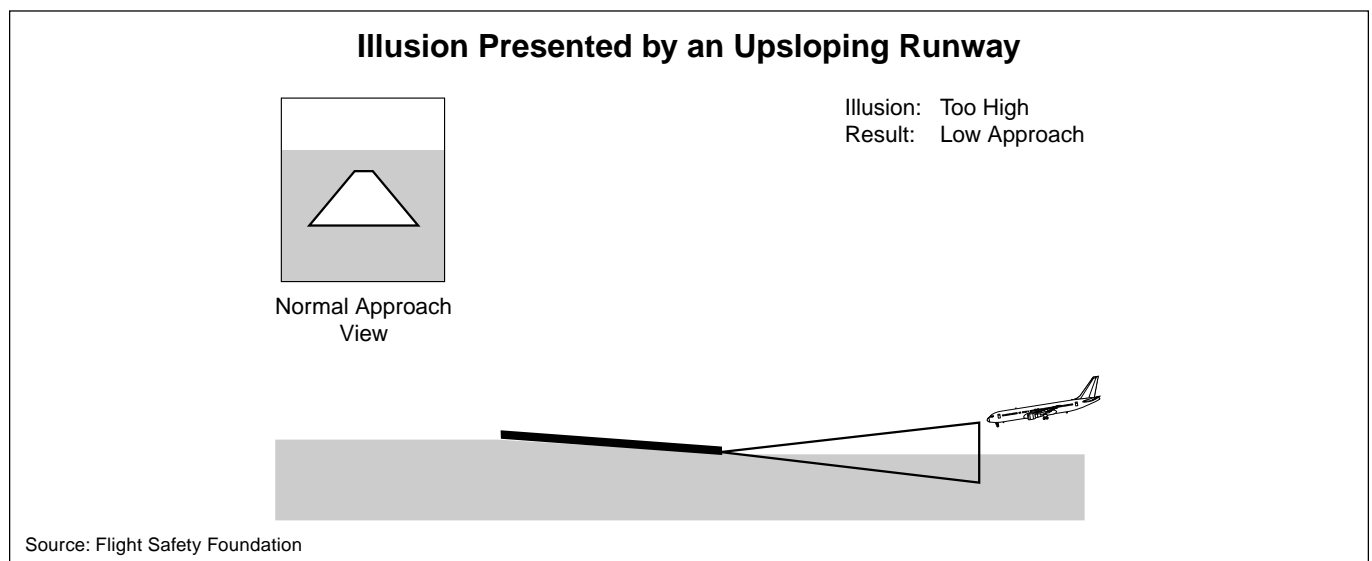
Figure 3

Sloped runways exacerbate the problems associated with black-hole illusions. An upsloping runway (Figure 3) creates an illusion of being too high, causing pilots to fly a low approach that might result in premature surface contact short of the runway. In one of the Boeing simulator experiments²⁹, 12 Boeing instructor-pilots, whose experience averaged 10,000 flight hours, flew visual approaches in black-hole conditions to an upsloping runway environment without the aid of an instrument landing system or an altimeter. Eleven of the 12 pilots flew into terrain or water short of the runway—in some instances, several miles from the runway.

In March 1996, the upsloping portion of a runway at Halifax International Airport in Nova Scotia, Canada, created an illusion of increased height for the crew of a Boeing 767. This black-hole illusion was so strong that, despite visual cues provided by the precision approach path indicator lights, the crew prematurely reduced power, which resulted in a short, hard landing that damaged the aircraft's tail.³⁶
