FLIGHT INSTRUMENT INFORMATION

FLIGHT OPERATIONS AERO 11

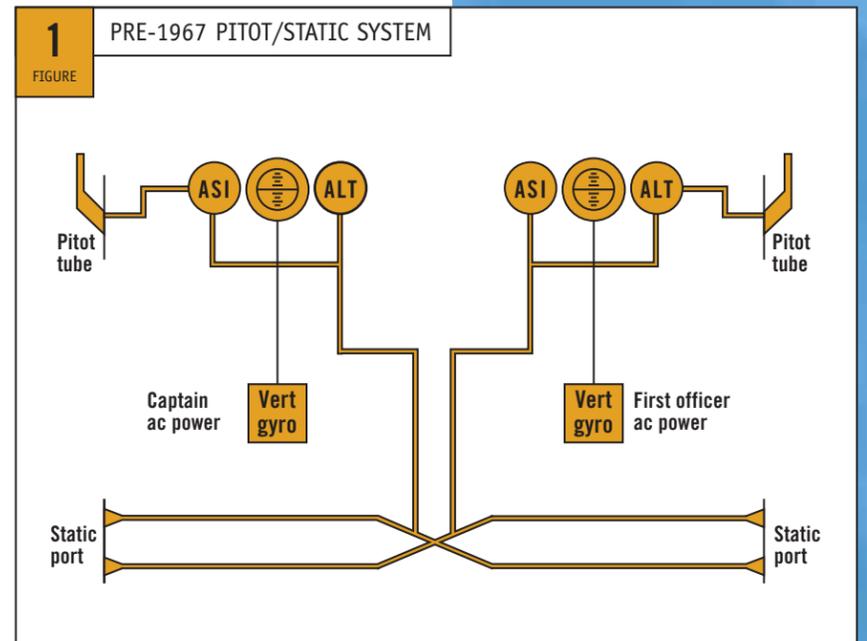
Pre-1967.

Only captain and first officer primary flight instruments, but no standby instruments, were installed on early Boeing commercial airplanes (fig. 1). The two artificial horizons (attitude indicators) are powered by analog signals from remotely located vertical gyros. Both gyros are lost if all the main airplane generators fail. Because of this, the U.S. Federal Aviation Administration required a third, panel-mounted gyro instrument to be installed in the center of the instrument panel on later models. The third gyro is ac powered by a static inverter that receives its dc power from the main airplane battery.

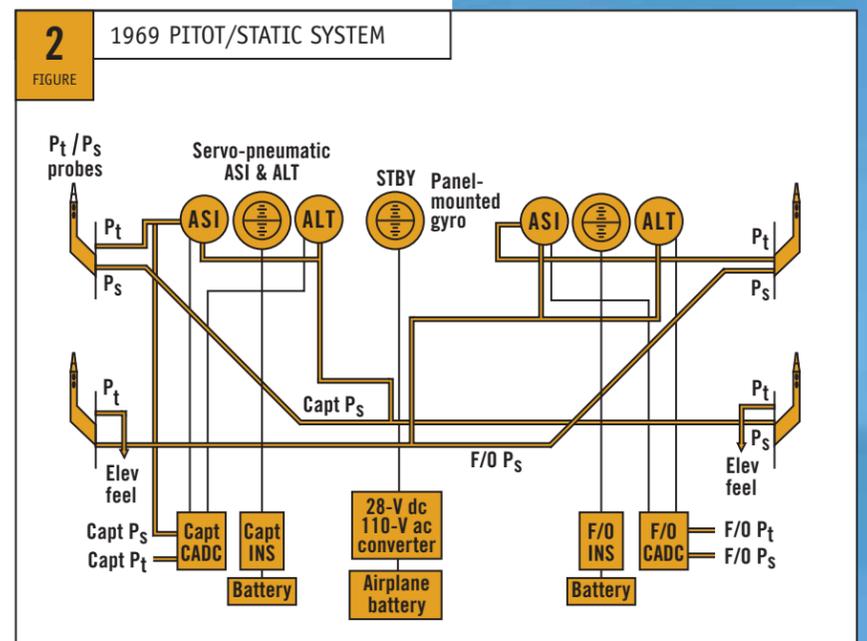
1969.

The airspeed indicators and altimeters directly receive pitot and static pressure information from left and right pitot probes and static pressure from two pairs of flush-mounted static ports (fig. 2). These indicators require electrical power only for lighting.

The altimeters and airspeed indicators were initially the same as the all-pneumatic type used in the 707 but were shortly replaced by a servo-pneumatic type. This type can operate in either of two modes: central air data computer (CADC) mode or all-pneumatic (backup) mode. The altimeters and airspeed indicators were normally driven by analog signals from their respective CADCs. The CADC added compensation for static source errors; if they lost power, however, the instruments reverted to the less precise, all-pneumatic mode. This generation of airplanes also integrated the static ports into pitot-static probes.

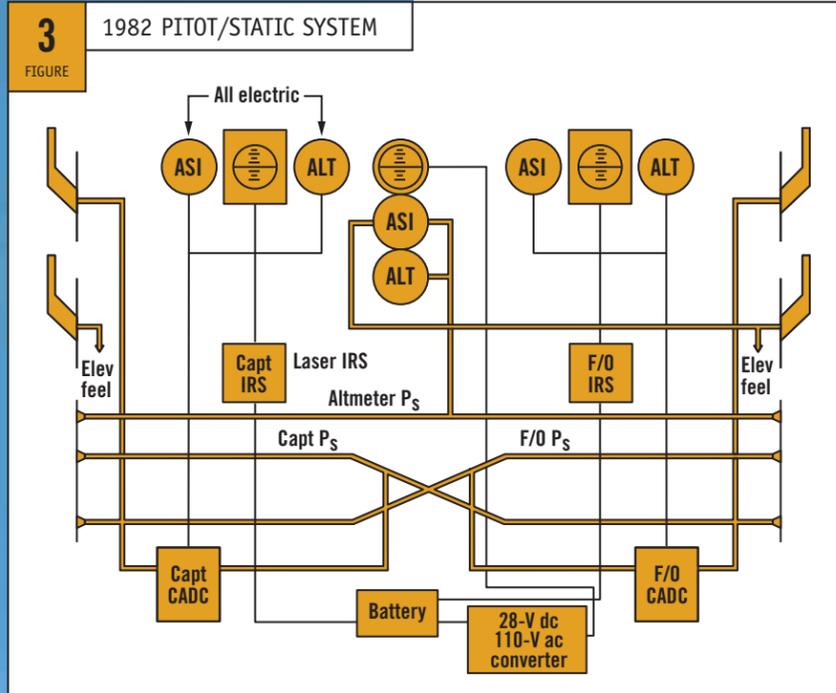
Eventually, the 747-200 evolved to all-electrical air-data instruments driven only by CADCs, with no pneumatic backup. At that time a third standby airspeed indicator and altimeter were added. These additional standby instruments were all-pneumatic and became the standard for all Boeing airplanes designed after 1969 and before the 777 in 1994 (fig. 3).

With the development of inertial navigation systems (INS), a new source of information for the captain and first officer attitude indicators was available. The standby attitude indicator power source remained ac from an inverter, powered by the airplane battery.

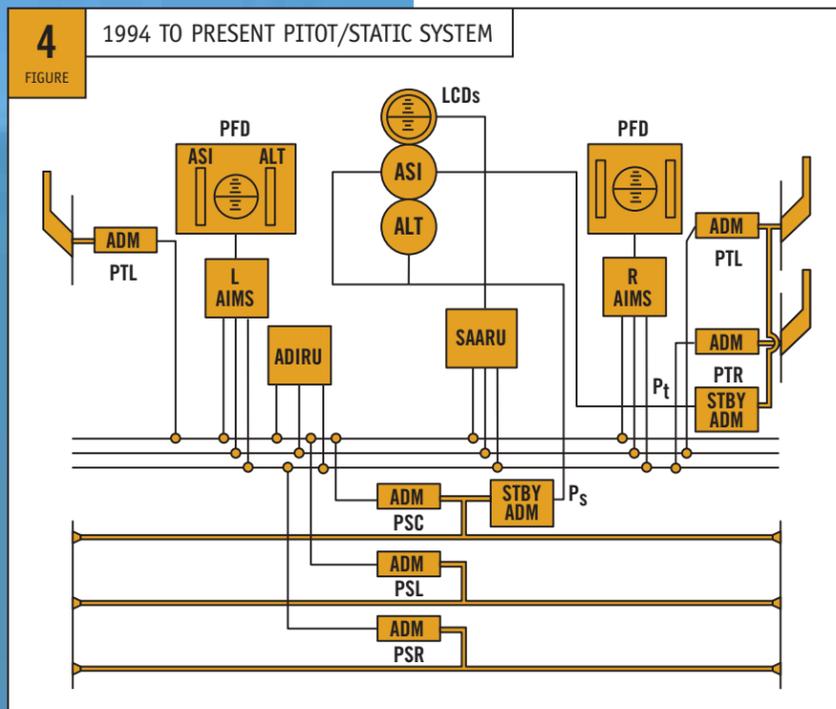
1994 to present.

The primary source for attitude, airspeed, and altitude is the air data inertial reference unit (ADIRU) (fig. 4). The attitude and air data signals are formatted for display by the airplane information management system. The ADIRU design differs from the traditional left-right system partitioning. The ADIRU is a single, fault-tolerant, high-integrity data source for both primary flight displays (PFD). The ADIRU uses multiple redundant inertial sensors for computing attitude and also selects a best attitude and airspeed from three pitot and static pressure sources. As a result it provides a single set of data for both the captain and first officer, eliminating cross-channel splits. The pitot and static pressures are measured by small air data modules (ADM) located as close as possible to the respective pressure sources. The ADMs transmit their pressures to the ADIRU through data buses. In the highly improbable event that the ADIRU totally fails, a secondary

attitude air data reference unit (SAARU) provides comparable attitude and air data to both PFDs. The SAARU also supplies standby attitude directly to an electronic standby horizon instrument. The standby airspeed indicator and altimeter, both electronic, receive pitot and static pressure from the standby ADMs. This design ensures that displayed data are immune to any first and most second failures of their respective sensors or pressure probes.
