Moment of Truth

Rigid adherence to procedures for takeoff weight, center of gravity and stabilizer trim setting reduces the likelihood of uncommanded or delayed rotation.

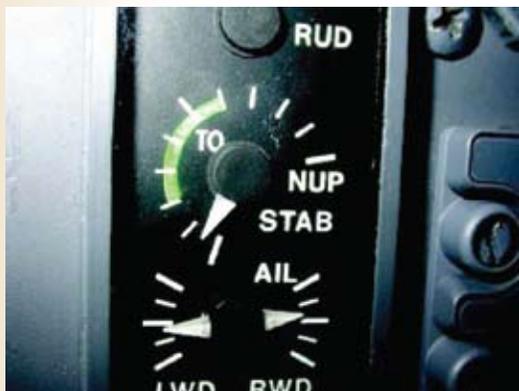
This Bombardier Challenger 600 pitch-trim position indicator is similar to one examined in the Teterboro crash.
