Lightning Strike, Loose Electrical Connector Disable Fokker 100 Hydraulic Systems

An in-flight lightning strike caused depletion of fluid from the main hydraulic systems, and the alternate anti-skid braking system failed, but none of the occupants was injured when the airplane veered off a wet runway during landing.

—
FSF Editorial Staff

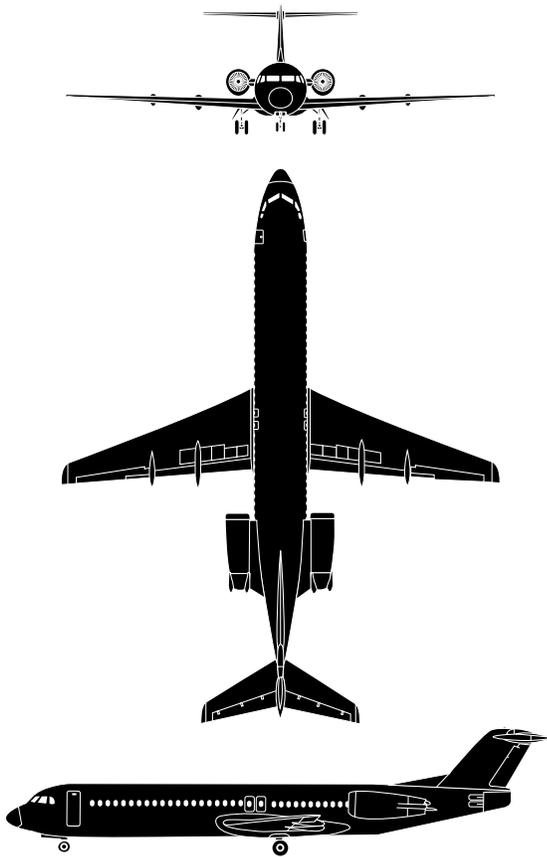
The Fokker 100, a short/medium-range jet transport, replaced the F28-4000 in 1987. Compared with its predecessor, the Fokker 100 has longer wings, a longer fuselage, Rolls-Royce Tay turbofan engines, an improved cabin and an improved flight deck with electronic flight instrument systems.

The airplane accommodates two pilots, three cabin attendants and up to 122 passengers. The standard cabin accommodates 107 passengers in five-abreast seating.

Each of the standard Tay 620 engines produces 61.6 kilonewtons (13,850 pounds thrust). Tay 650 engines, each producing 67.2 kilonewtons (15,100 pounds thrust), became available as an option in 1989. Standard fuel capacity is 12,820 liters (3,387 gallons).
