Flight Crew Incapacitation Follows Learjet 35 Cabin Depressurization

—
FSF Editorial Staff

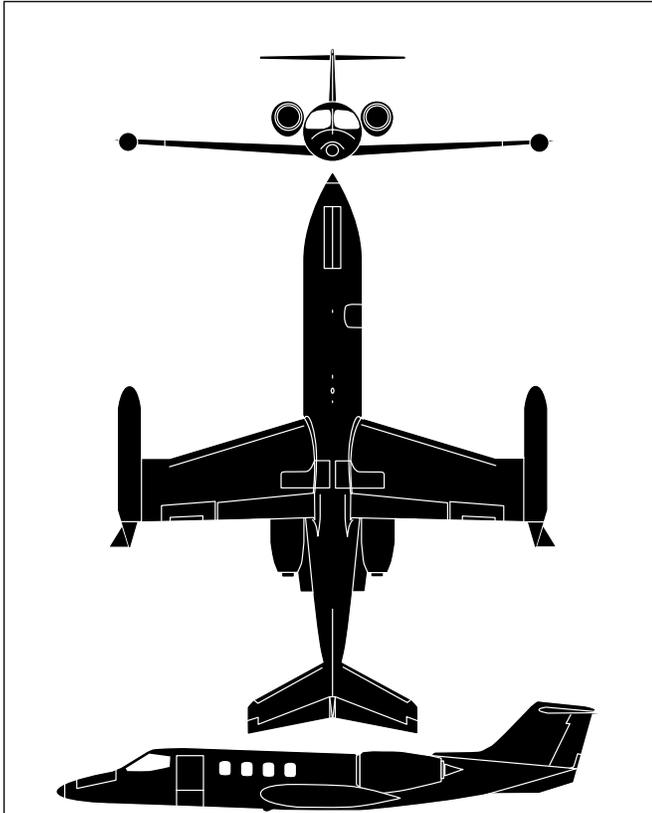
Gates Learjet 35

The Learjet 35 made its first flight in 1973; deliveries began in 1974. The airplane is similar to the Learjet 25 but has turbofan engines rather than turbojet engines, a longer fuselage and longer wings. Each of the Honeywell (formerly Garrett and AlliedSignal) TFE731-2-2B engines is rated at 3,500 pounds thrust (15.6 kilonewtons). Usable fuel capacity is 925 gallons (3,501 liters).
