Misrigged Elevator and Aft Loading Cause Loss of Control of Raytheon Beech 1900D

Limited nose-down elevator travel and an excessive aft center of gravity rendered the twin-turboprop airplane uncontrollable in pitch on takeoff from Charlotte, North Carolina, U.S. The accident report cited incorrect rigging of the elevator-control system and deficiencies in maintenance oversight and in calculation of passenger weights and baggage weights.

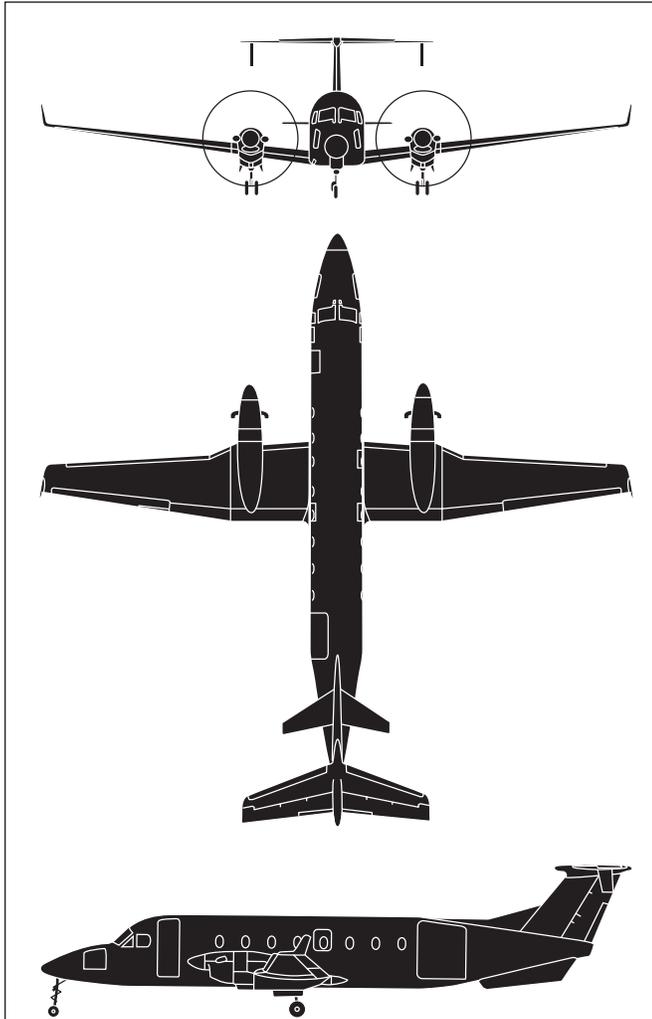
Raytheon Beech 1900D

The Beech 1900D is a twin-turboprop regional transport that entered service in 1991 and currently is manufactured by Raytheon Aircraft Co. The airplane is a derivative of the Beech 1900, which first flew in 1982. The 1900D has a flat floor, a maximum cabin height of 5.9 feet (1.8 meters) and 28.5 percent more cabin volume than its predecessor, the Beech 1900C. Standard accommodation is for two flight crew members and 19 passengers.
