Pilot Becomes Spatially Disoriented, Aircraft Breaks Apart During Descent

A Raytheon Super King Air 200 was transporting members of a collegiate basketball team in instrument meteorological conditions when the alternating-current electrical system malfunctioned. The report said that the pilot became spatially disoriented. The pilot's control inputs placed a large aerodynamic load on the aircraft and caused it to break apart at low altitude.

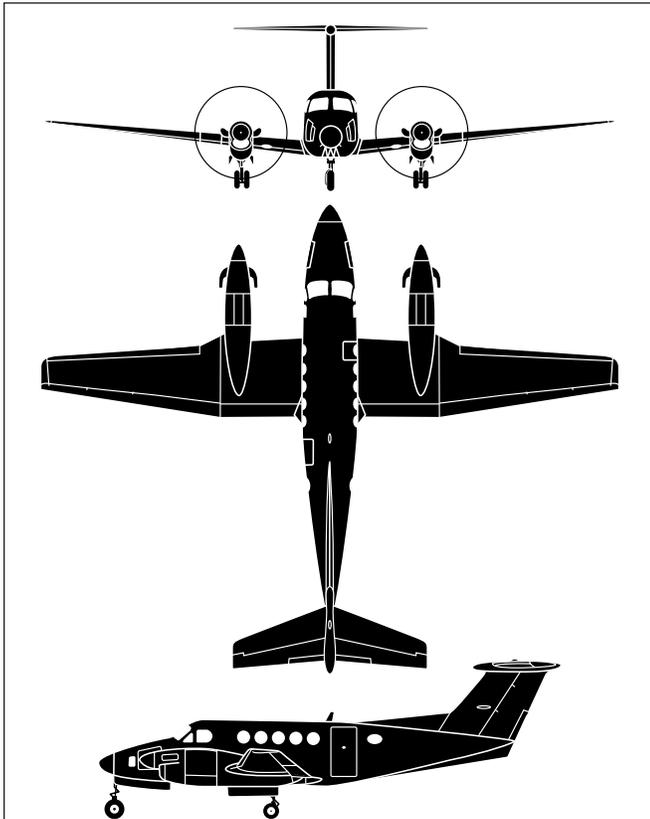
Design of the Raytheon Super King Air 200 business and utility twin-turboprop aircraft began in 1970. The first prototype flew in 1972. The aircraft has the same basic fuselage as the King Air 100 and has increased wingspan, more powerful engines, increased fuel capacity, increased cabin pressurization and a higher gross weight.
