Loss of Control Occurs During Pilot's Attempt to Return to Departure Airport

Contamination by snow, an over-gross-weight condition and the pilot's failure to adhere to the recommended wind shear recovery procedure affected the air-taxi aircraft's performance during departure from an airport in Canada. The aircraft stalled and descended into a river, where three survivors later drowned.

—
FSF Editorial Staff

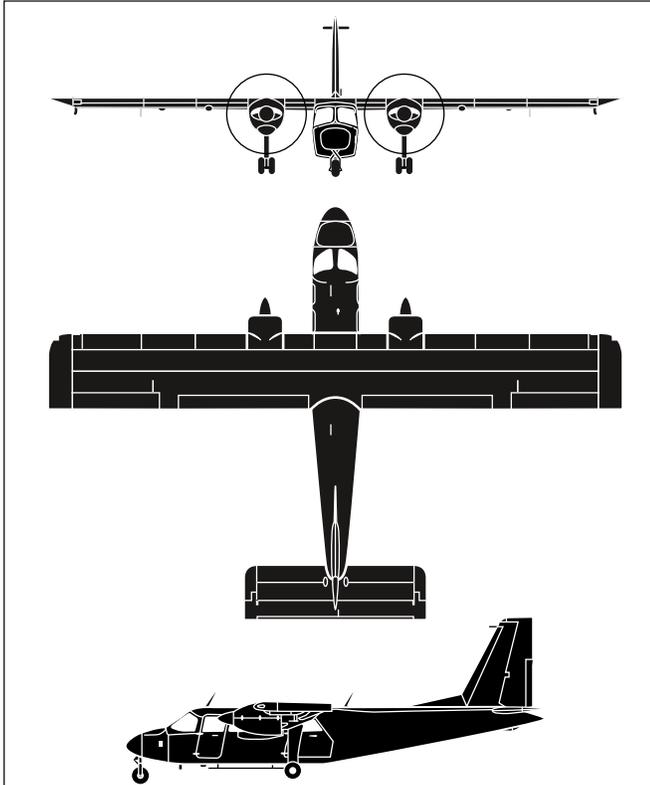
Britten-Norman BN-2A Islander

The production prototype of the Britten-Norman BN-2 Islander was flown for the first time in 1966. Deliveries began in 1967. The BN-2A was introduced in 1969 with a higher maximum takeoff weight — 6,600 pounds (2,994 kilograms), up from 6,000 pounds (2,722 kilograms).
