Low Engine Oil Pressure, Severe Vibration Prompt Pilatus PC-12 Forced Landing

The pilot did not follow the prescribed emergency procedure for a low-oil-pressure indication and eventually had to shut down the engine because of severe vibration. Three of the 10 occupants were seriously injured when the pressurized, single-engine turboprop aircraft was landed in a bog. The investigation did not determine why the oil-flow interruption occurred.

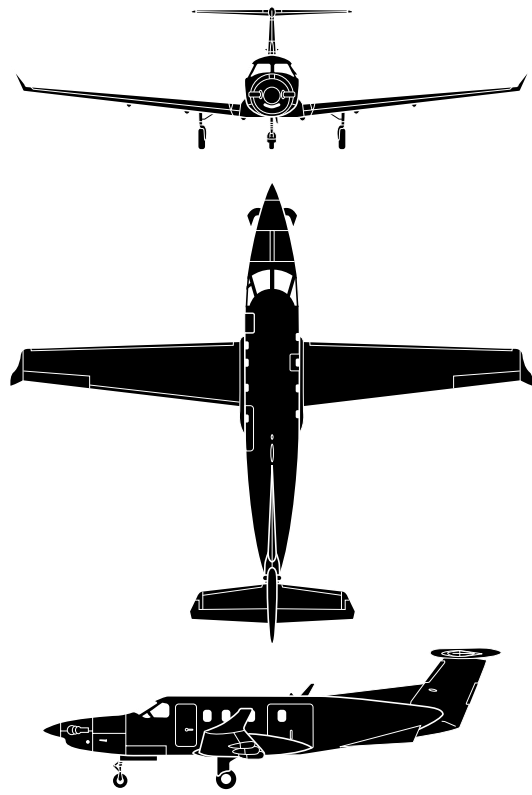
The Pilatus PC-12 is a pressurized utility/business aircraft powered by a turboprop engine. The first flight was conducted in May 1991. Preproduction design modifications included winglets, longer wingspan, larger dorsal fin and ventral strakes. Deliveries began in September 1994.

The fuel tanks are in the wings. Maximum usable fuel capacity is 400 gallons (1,514 liters).
