Operational Liaison Meeting FBW aircraft

Protections against fuel vapor ignition

Protections Against Fuel Vapor Ignition

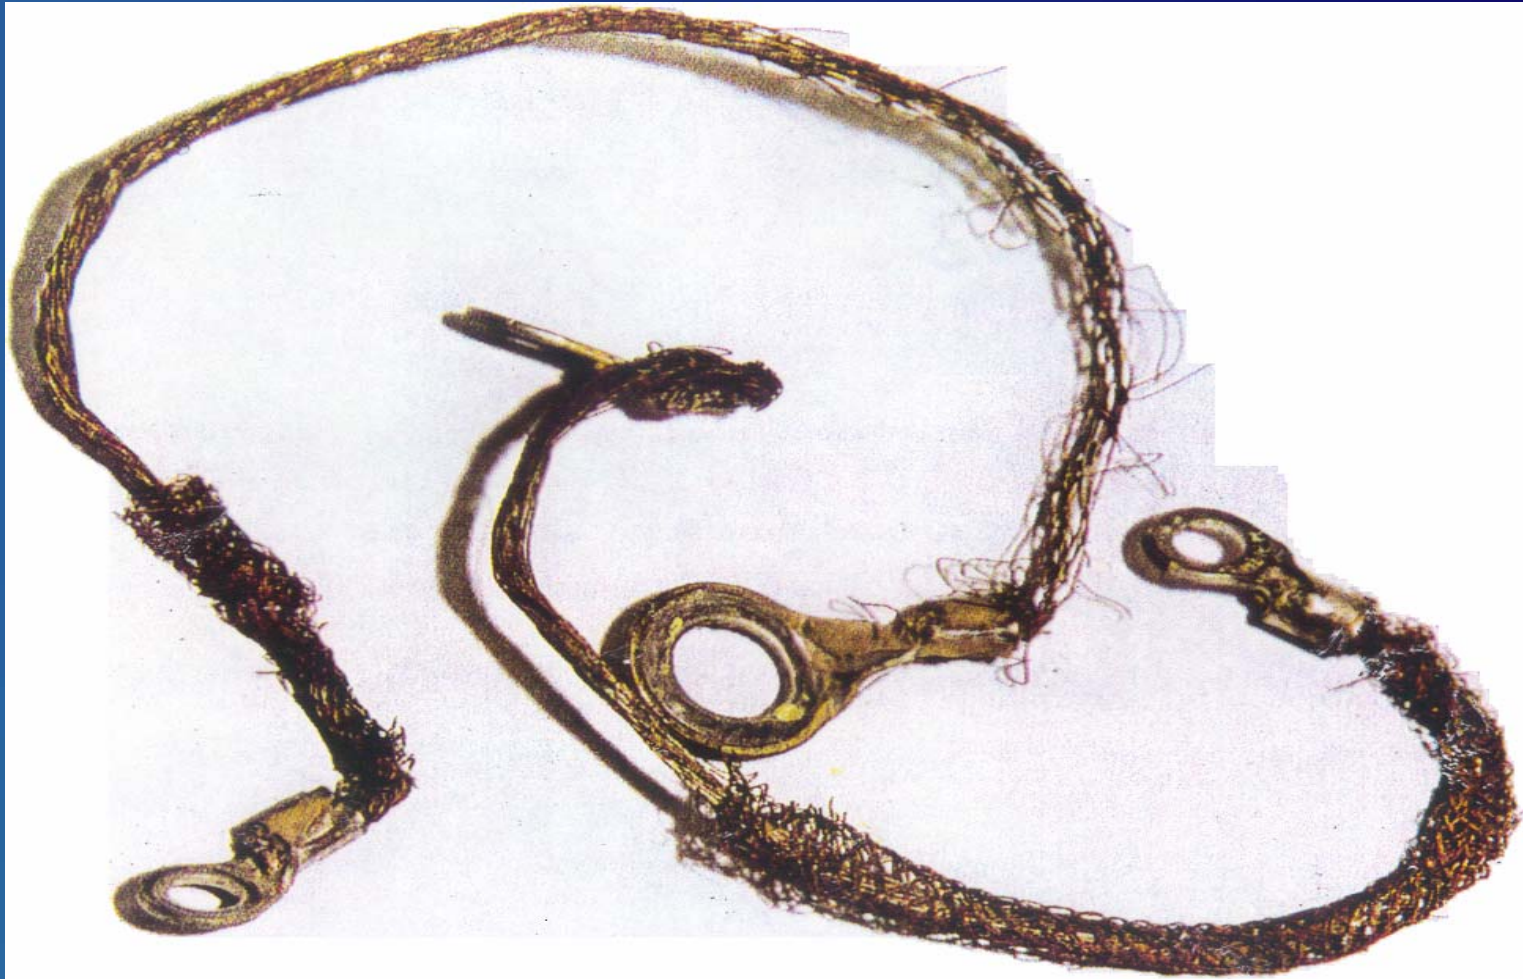
Bonding Lead (damaged)

- All structures are protected against lightning strikes and static electricity through electrical bonding (wires directly connected to the fuselage) to avoid accumulation of electricity
- Protection of all wires against short circuit and induced electrical fields
- Automatic tripping of circuit breaker to electrically isolate a failed system
- A320 FCOM recommendation (FCOM 3.04.24):
