Flight Safety

NOVEMBER 2004

RVSM Heightens
Need for Precision in
Altitude Measurement

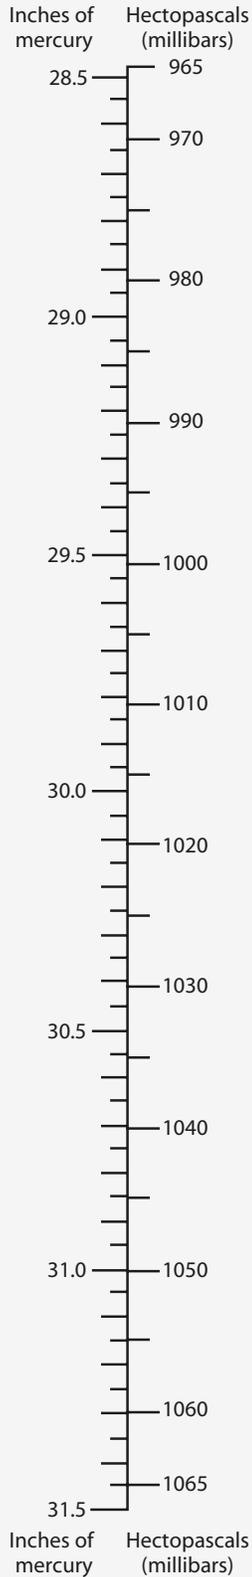
Figure 1
Altimeter-setting Conversion Table

Many civil aviation authorities use hectopascals (millibars), to measure barometric pressure; others use inches of mercury (Figure 1); if a pilot confuses the two and mis-sets the altimeter, the result can mean that the aircraft is hundreds of feet lower (or higher) than the indicated altitude (Figure 2; Figure 3, page 8).¹⁹

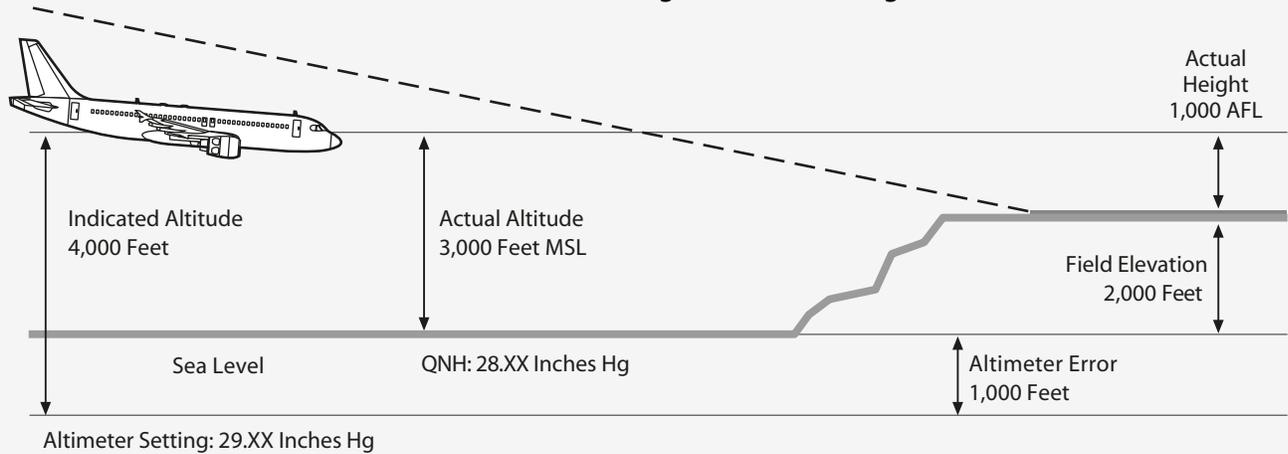
Figure 4
Effect of a One-inch-high Altimeter Setting

AFL = Above field level MSL = Mean sea level Hg = Mercury

QNH = Altimeter setting that causes altimeter to indicate height above mean sea level (thus, field elevation at touchdown)
