FLIGHT SAFETY FOUNDATION

OCTOBER 1998

FLIGHT SAFETY

International Regulations Redefine V1

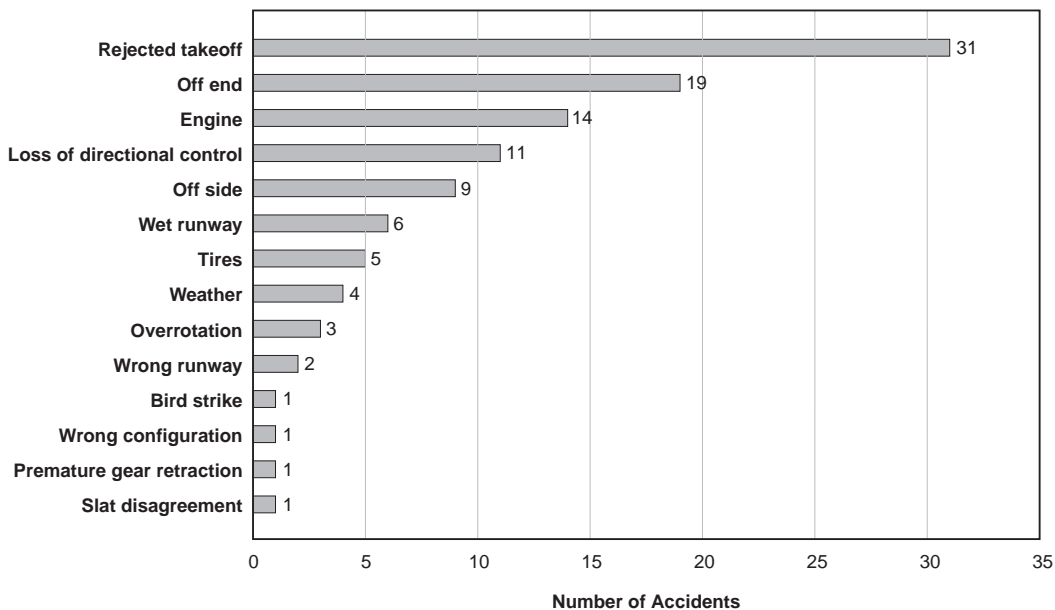
Figure 3

Events Involved in Commercial, Turbine-powered Airplane Accidents, 1988–1997

Note: Statistics apply to civilian, commercial jet airplanes weighing more than 60,000 pounds (27,216 kilograms), except those manufactured in the Commonwealth of Independent States (former Soviet Union).

Source: Boeing Commercial Airplane Group

In its 1990 report, NTSB said, "Based on an analysis of its data for transport-category aircraft, Boeing projected one RTO in every 3,000 takeoffs and one high-speed RTO in every 150,000 takeoffs."² (A chart from the NTSB report of events causing RTO accidents and incidents is shown in Figure 2. A chart by Boeing of events that have caused recent takeoff accidents is shown in Figure 3, page 8).

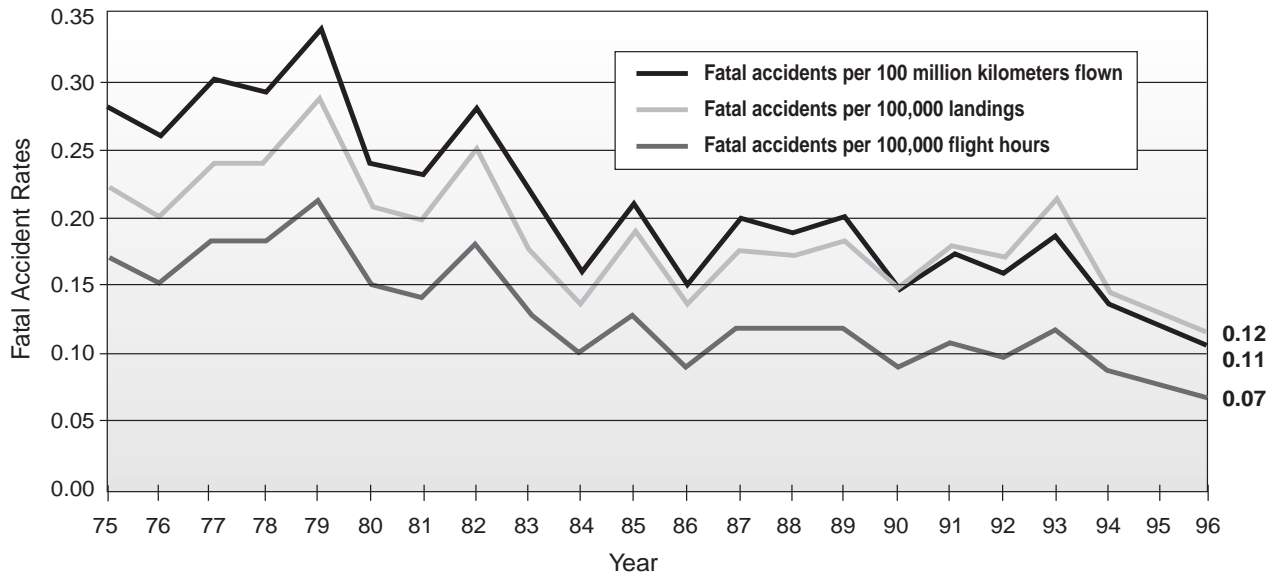
Worldwide Airplane Fatal Accident Rates — Scheduled Passenger Services

Source: U.K. Civil Aviation Authority and International Civil Aviation Organization

Figure 3 (page 21) shows that although there were increases in some years, the rates at which fatal accidents occurred in scheduled passenger operations worldwide have decreased significantly since 1975. The data do not include accidents in the CIS.
