Contents

1.6 Aircraft Information	8
1.6.1 General information.....	8
1.6.2 Aircraft general description	8
1.6.3 EFIS/ECAM	9
1.6.3.1 Engine and Warning Display	10
1.6.3.2 System Display	10

1.6.8 Fuel system SD page	13
1.6.9 Fuel system general	14
1.6.9.1 Fuel tanks layout.....	14
1.6.9.2 Pump and valve layout	16
1.6.9.3 Fuel control system	16

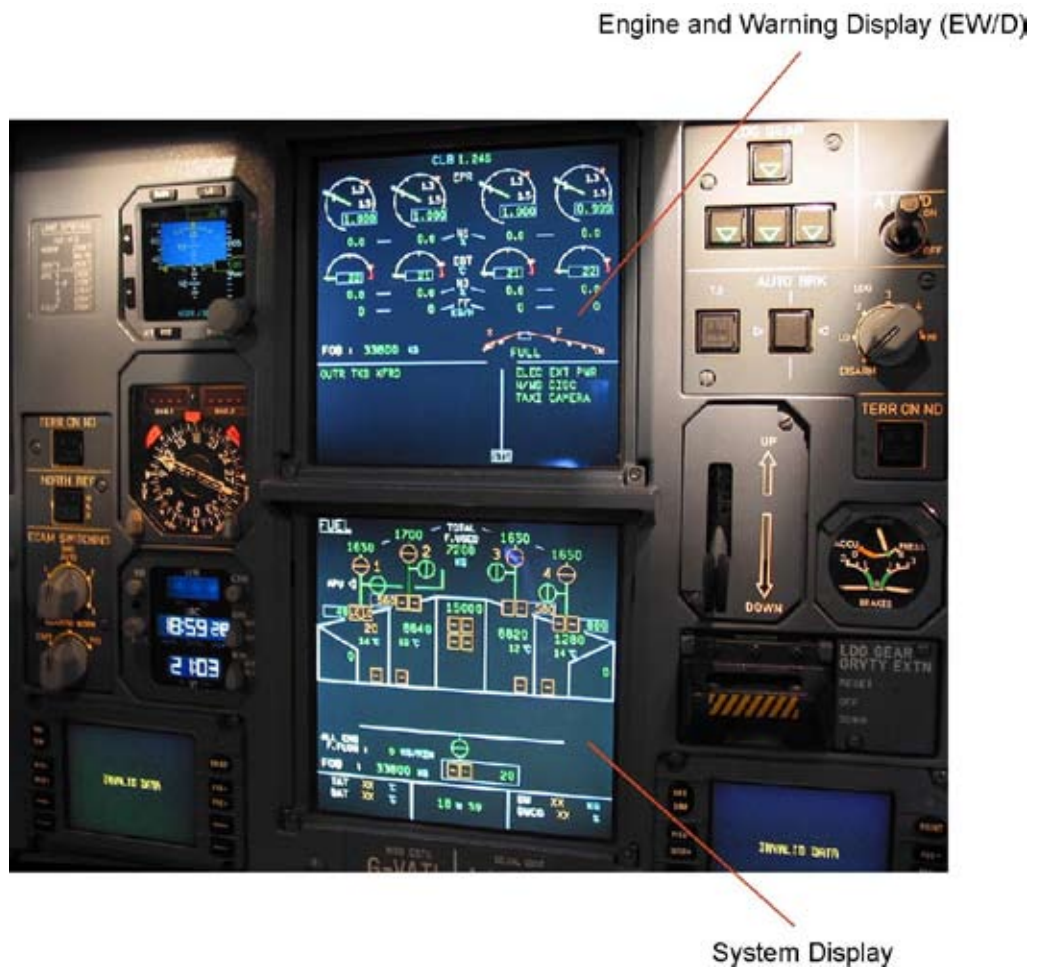
Figure 1
Upper and Lower ECAM Displays

The two central displays, mounted vertically, form the Electronic Centralised Aircraft Monitoring (ECAM) system. The upper display is the Engine and Warning Display (EW/D), and the lower display is the System Display (SD).

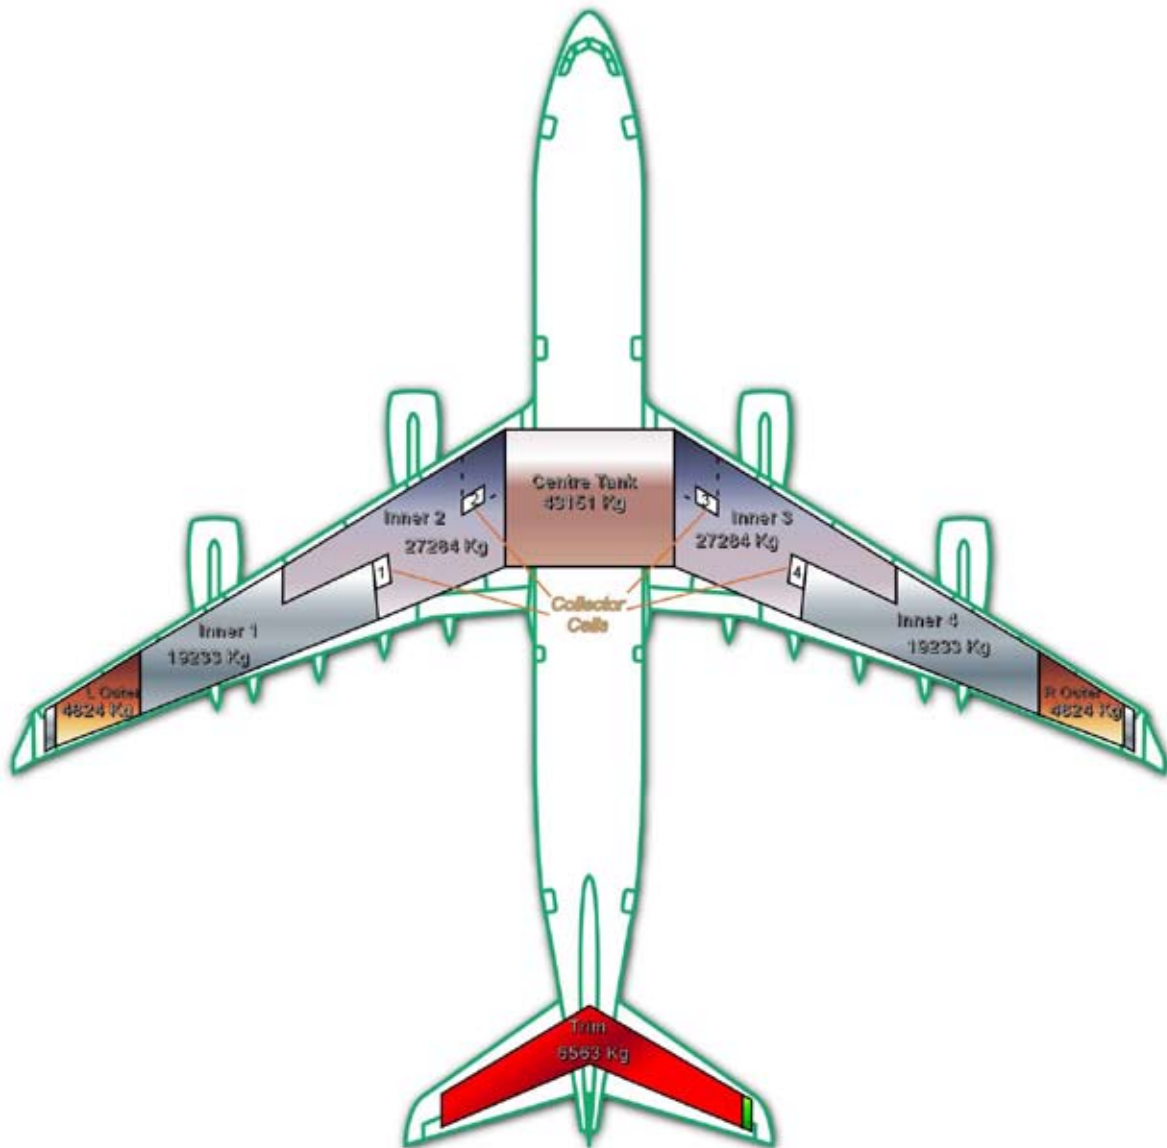
Figure 3

The fuel on the A340-600 is stored within eight separate fuel tanks as shown in Figure 3. These tanks are identified as:

A collector cell within each inner fuel tank provides fuel for the main and standby engine-feed fuel pumps. During normal operation, and with fuel in the inner tank, jet pumps keep the respective collector cell full of fuel.

Vent surge tanks, installed outboard of each outer tank and to the right of the trim tank, provide tank venting.

A340-600 Fuel Tanks Layout

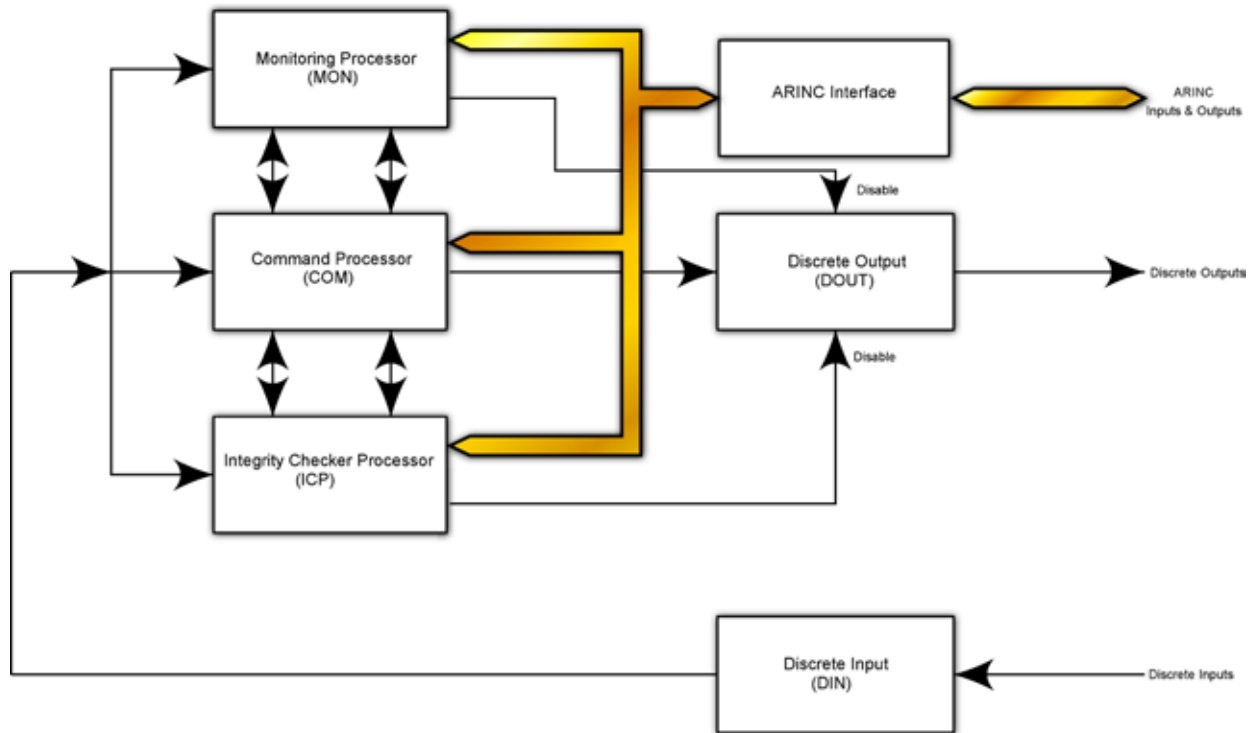
The computer architecture is shown in simplified form in Figure 4 below:

An FCMC consists of several separate circuit boards, each with a specific function. These functions are: a command/monitor board, an integrity check board, discrete¹ input boards and discrete output boards. The architecture within the unit consist of a command processor (COM), a monitor processor (MON), an integrity check processor (ICP), discrete input (DIN), discrete output (DOUT) and the ARINC interface. DIN takes the discrete inputs from the various pumps, valves and switches in the fuel system and processes the analogue data into digital signals for later processing in the COM and MON.

FCMC Simplified Block diagram

DOUT takes instructions from the COM and converts the digital signals into analogue commands for control of the pumps, valves and overhead panel indications. The DOUT is only able to output commands when the FCMC is master. The ICP and MON also have the ability to isolate the DOUT in the event of detected failures.

The COM carries out the control function of the system and uses the inputs from DIN and the ARINC interface to make decisions on valve control, pump control, warning indications, fuel quantity and display indications. The COM communicates these decisions via the DOUT or the ARINC interface to the various external systems. The MON carries out the same computations and compares the outputs from the COM with those decisions made by the MON; a discrepancy between the two processors generates a COM/MON comparison failure and an FCMC fault.

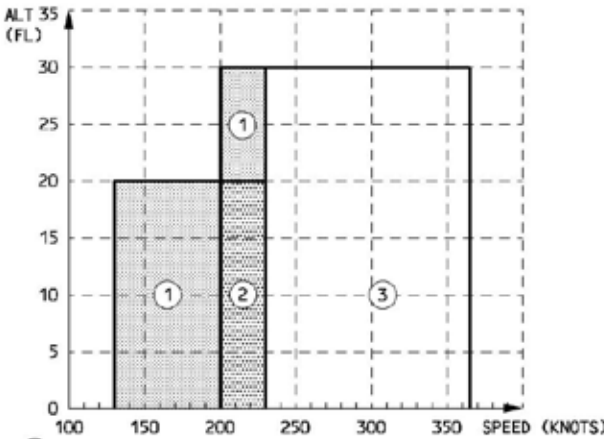
<p>ALT 35 (FL)</p> <p>30 25 20 15 10 5 0</p> <p>100 150 200 250 300 350 SPEED (KNOTS)</p> <p>① STARTER-ASSISTED.</p> <p>② STARTER-ASSISTED OR WINDMILLING QUICK RELIGHT.</p> <p>③ STABILIZED WINDMILLING START.</p>

Mod : 50868
FADEC L4.1.3 : windmilling above 230 kts, instead of 250 kts.

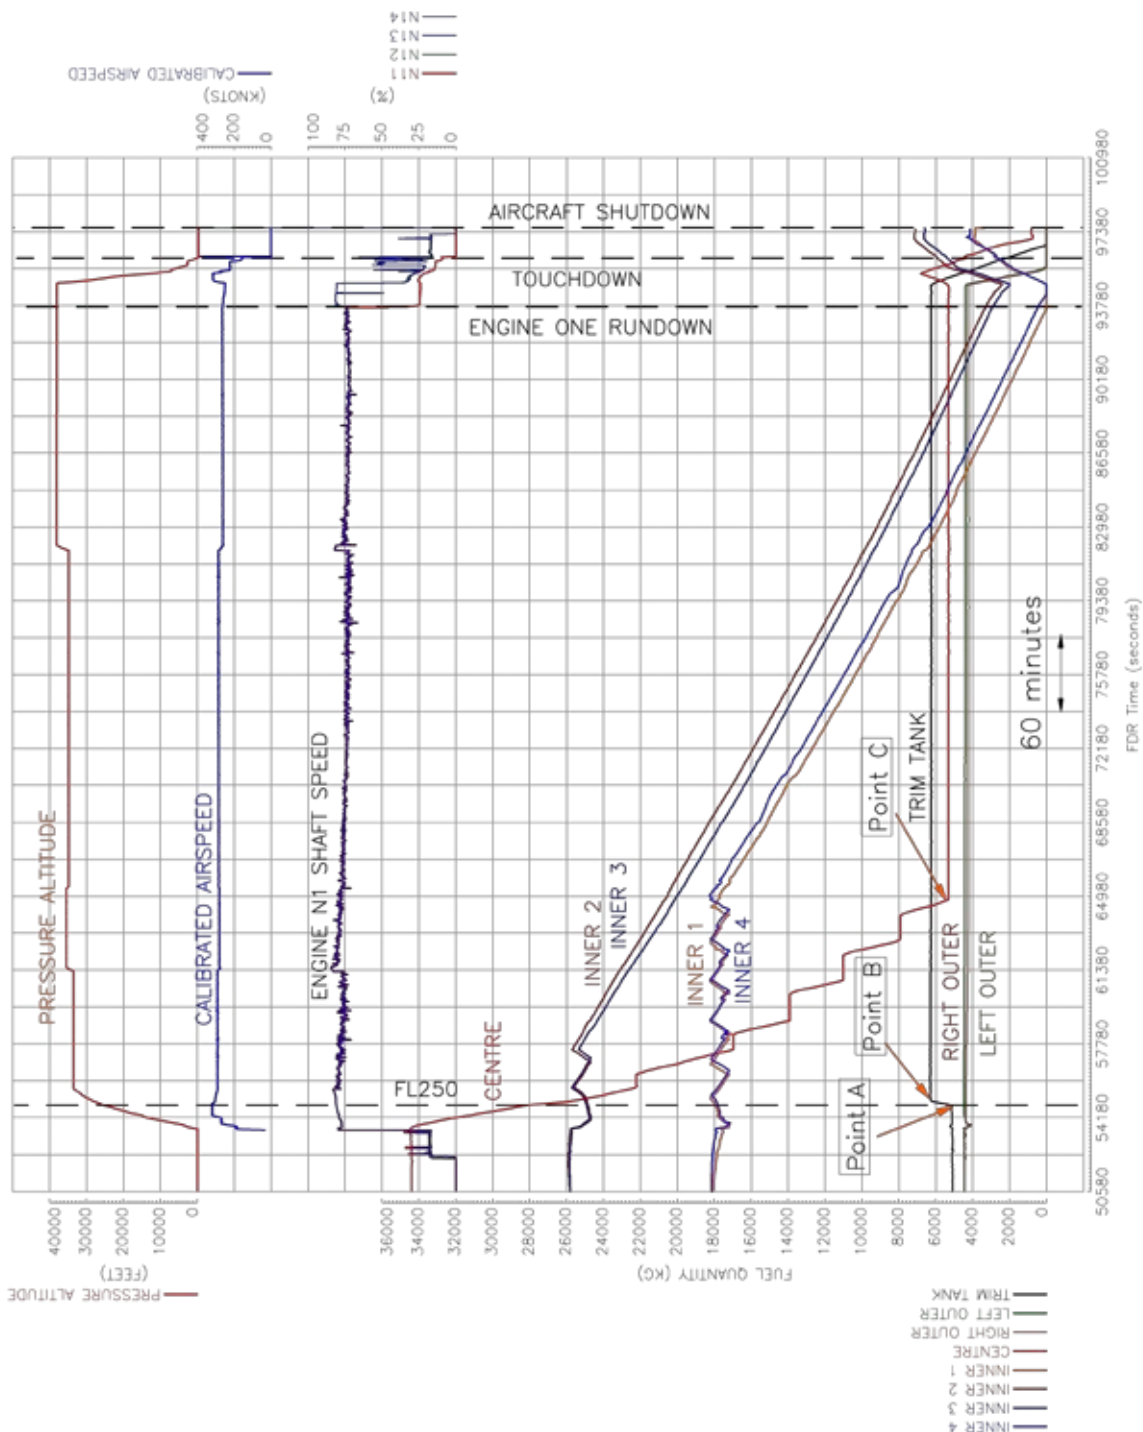
Figure 1

Flight Data Recorder Graphs

Relevant parameter from the recorded flight data are presented in graphical form in Figures 1, 2 and 3 at Appendix I.

Takeoff occurred at about 1621 hrs with a total recorded fuel quantity of 135,400 kg⁸. Shortly after takeoff an autopilot was engaged. The aircraft climbed and when it was at about FL250 the trim tank quantity started to increase (see Appendix I, Figure 1, Point A). The aircraft continued to climb until it reached about FL335 at about 1655 hrs. By then the trim tank quantity had stabilised at about 6,280 kg (Figure 1, Point B).

At about 1928 hrs at FL354, the centre fuel tank quantity stabilised at about 5,312 kg (Figure 1, Point C).
