A slippery business

By Marcus Blomlöf, Supervisor Stockholm Arlanda TWR

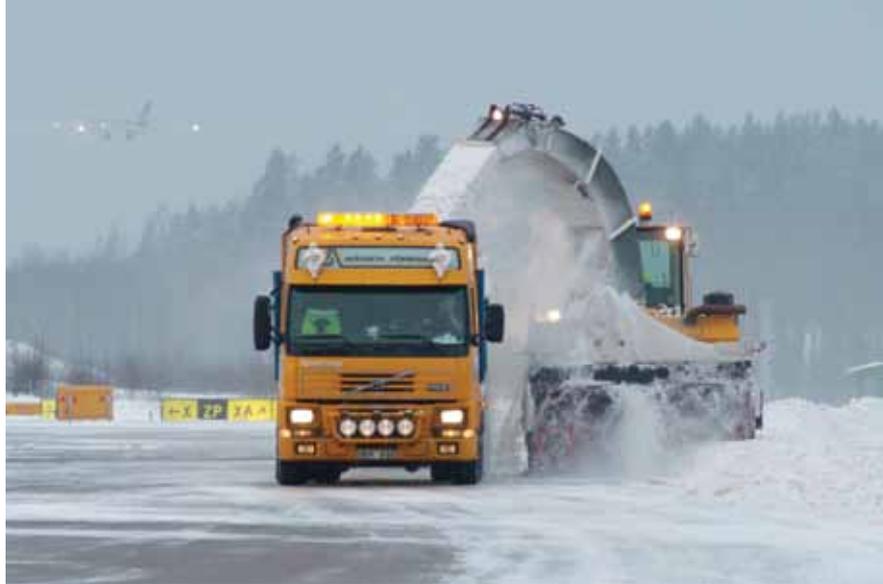
The drivers of the trucks, ploughs, blow sweepers, snow blowers etc. are typically seasonal employees, making an extensive training program before each winter season necessary.

The drivers of the trucks, ploughs, blow sweepers, snow blowers etc. are typically seasonal employees, making an extensive training program before each winter season necessary. It is important to ensure not only how to handle the vehicles, but also how to use the radio and how to navigate the airport including where clearance is needed and where it is not.
