The 156-tonne GIMLI GLIDER

It's the 20th anniversary of aviation's most famous deadstick landing.

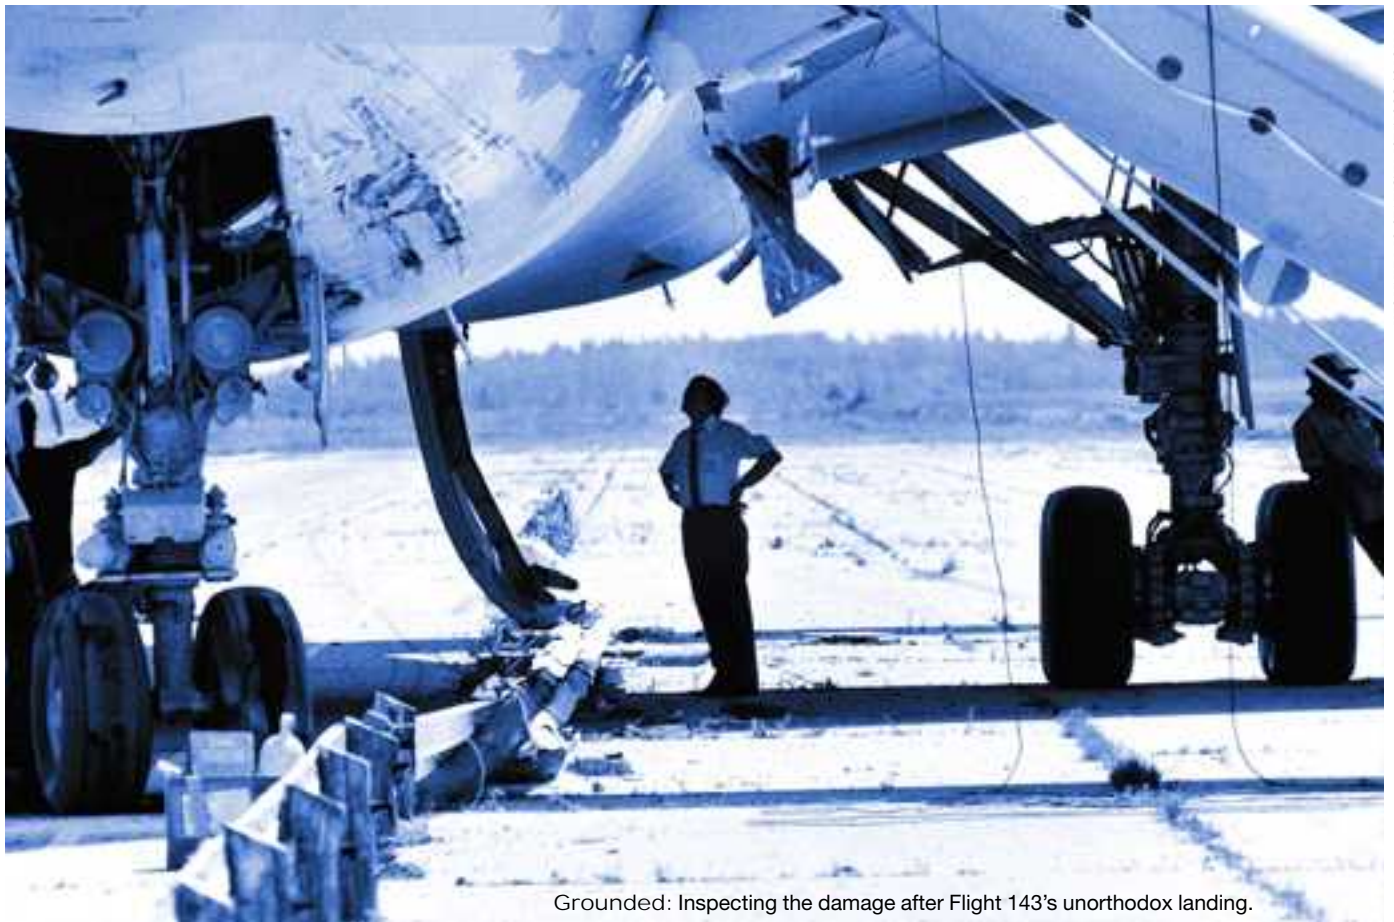
Grounded: Inspecting the damage after Flight 143's unorthodox landing.
