FLIGHT SAFETY

D I G E S T

Pilot–Air Traffic Control Communications: It's Not (Only) What You Say, It's How You Say It

Vol. 14 No. 7

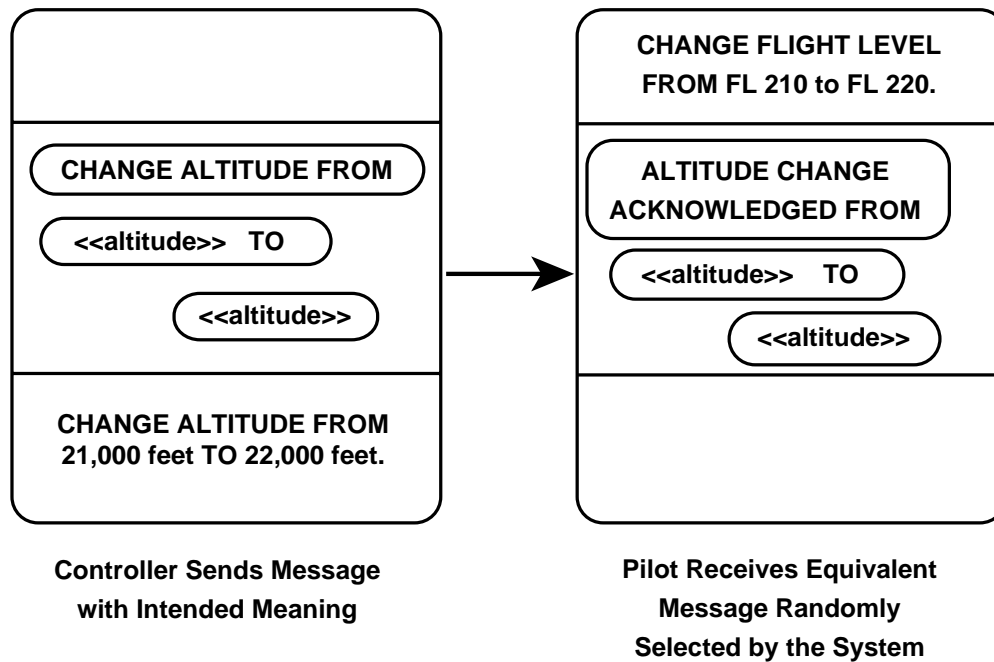
Figure 4

AIR System Conversion to Alternative Formulations of Instructions
